# Champlain Towers South Collapse Investigation

Matthew Fadden, PhD, PE  
*Managing Director and Principal  
Walter P Moore Associates, Inc.*

Gary Klein, PE, SE  
*Vice President and Senior Principal  
Wiss, Janney, Elstner Associates, Inc.*

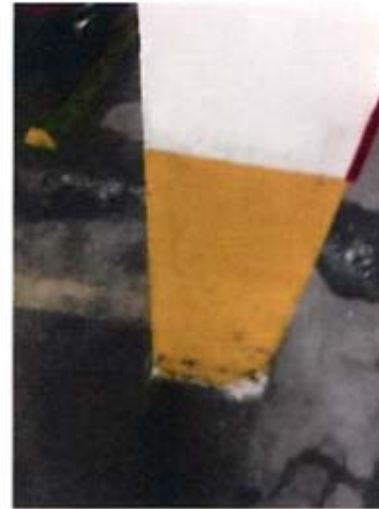
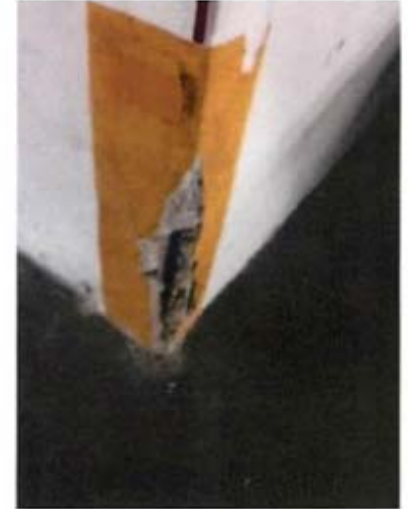
- Abundant cracking and spalling in garage with calcium carbonate leaching
- Previous repairs failing due to poor workmanship
- Concrete repair recommended following standard practices
- Recommend that the entrance and pool decks slabs showing distress be removed and replaced

Figure J1: Typical cracking and spalling at parking garage columns

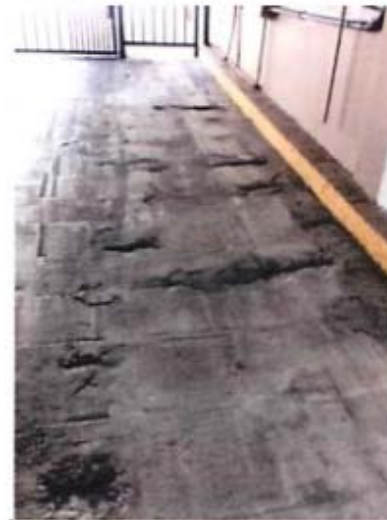
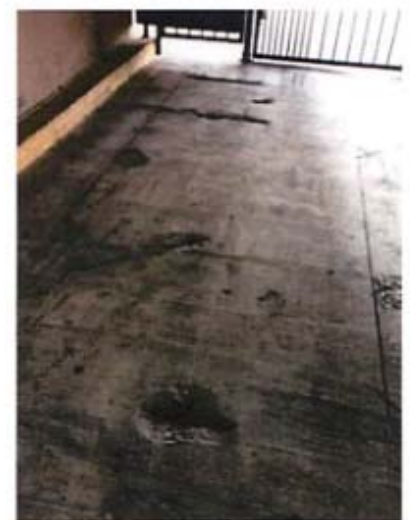
Figure J2: Spalling with exposed steel reinforcement at topside of garage deck.

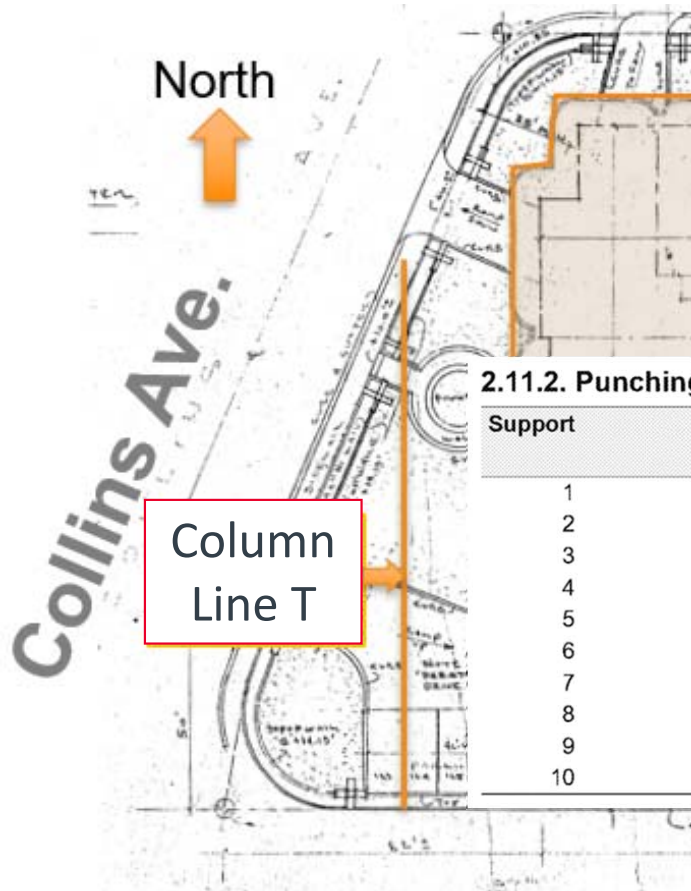
- Recertification engineer analyzed the slab along Column Line T
- Punching shear results were exceeded in every calculation iteration.

**2.11.2. Punching Shear Results**

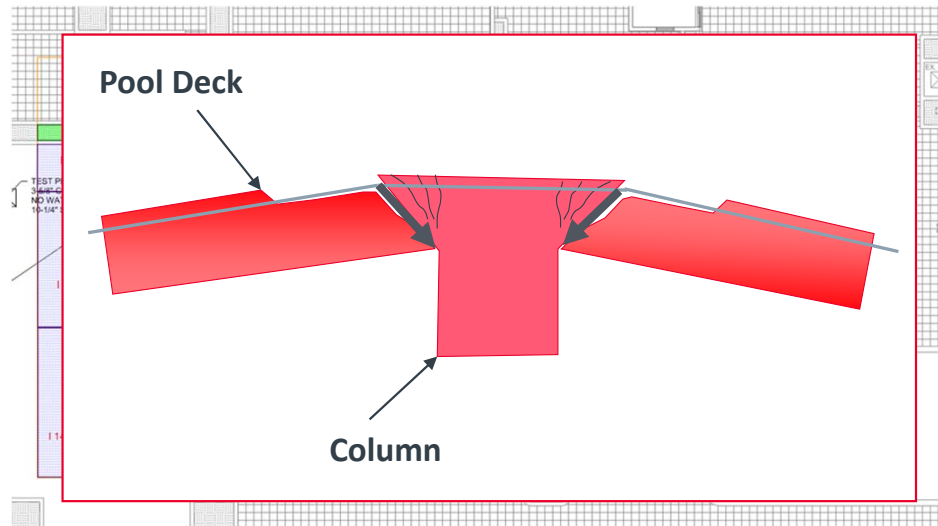
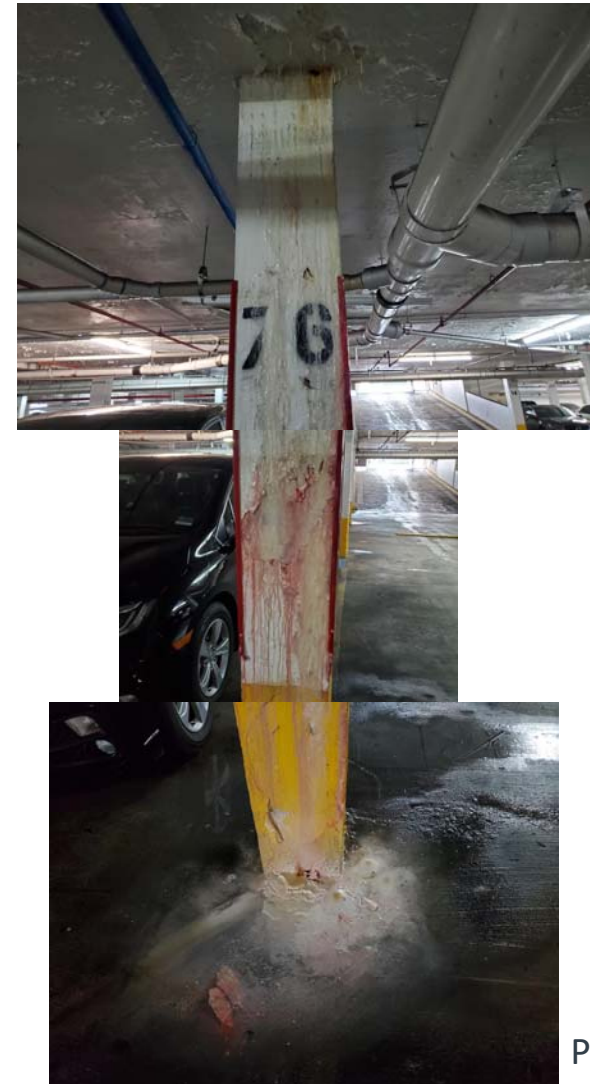
## L13.1 Slab/Column Distress – Nov. 13, 2020

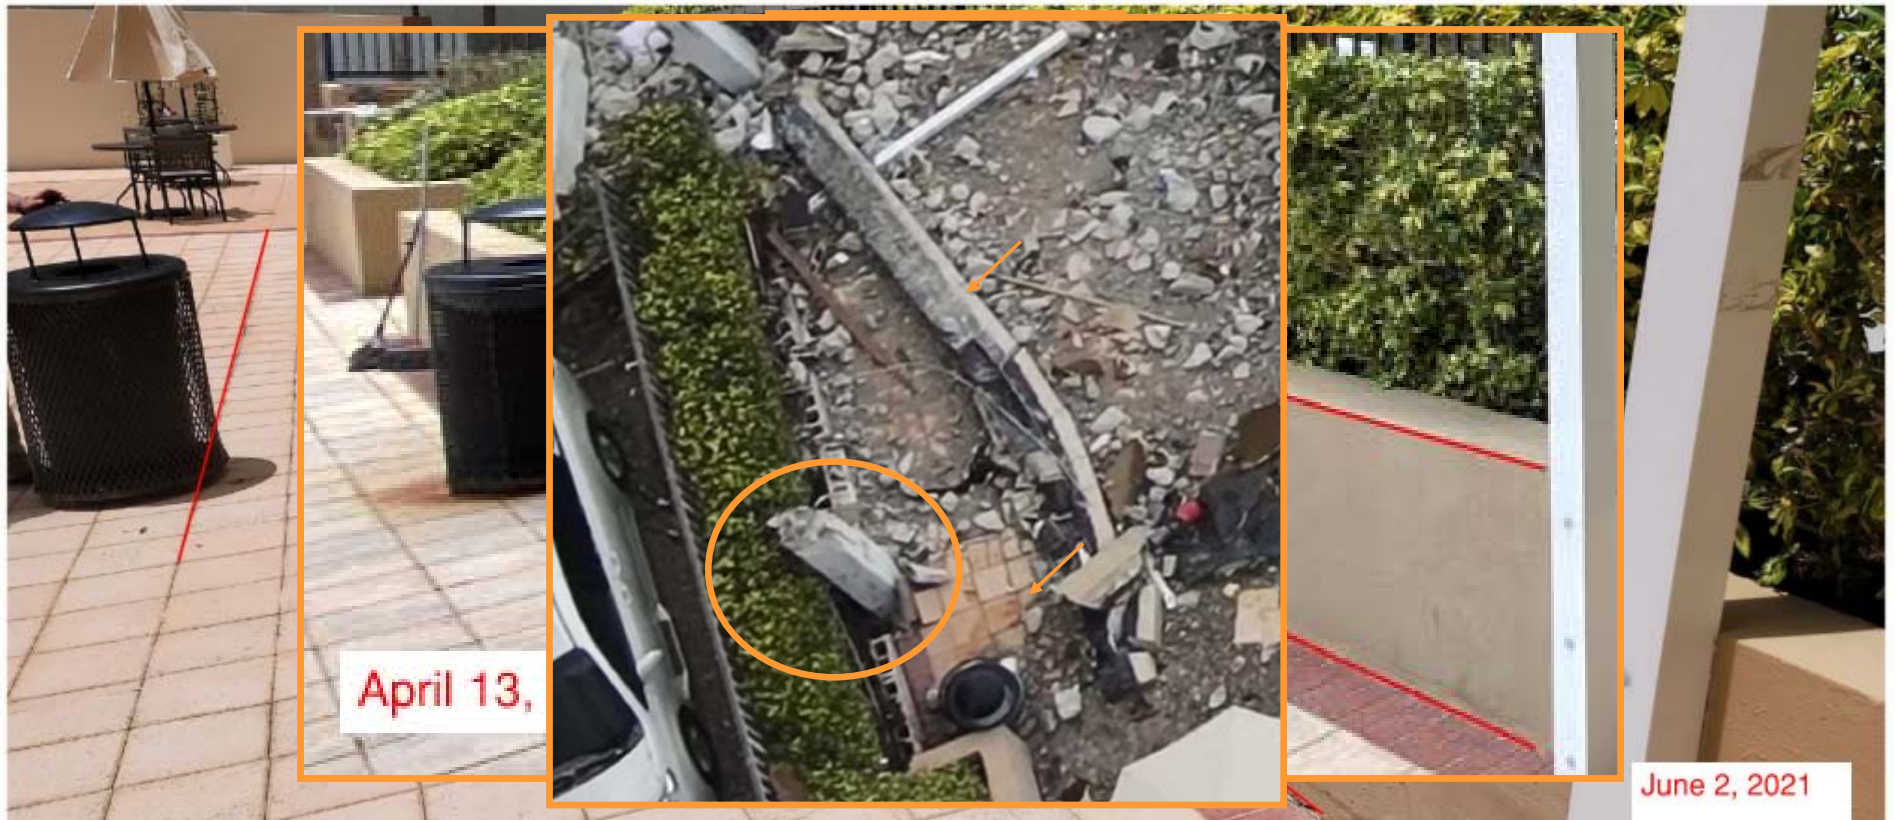
## K13.1 Slab/Planter Distress - June 2, 2021

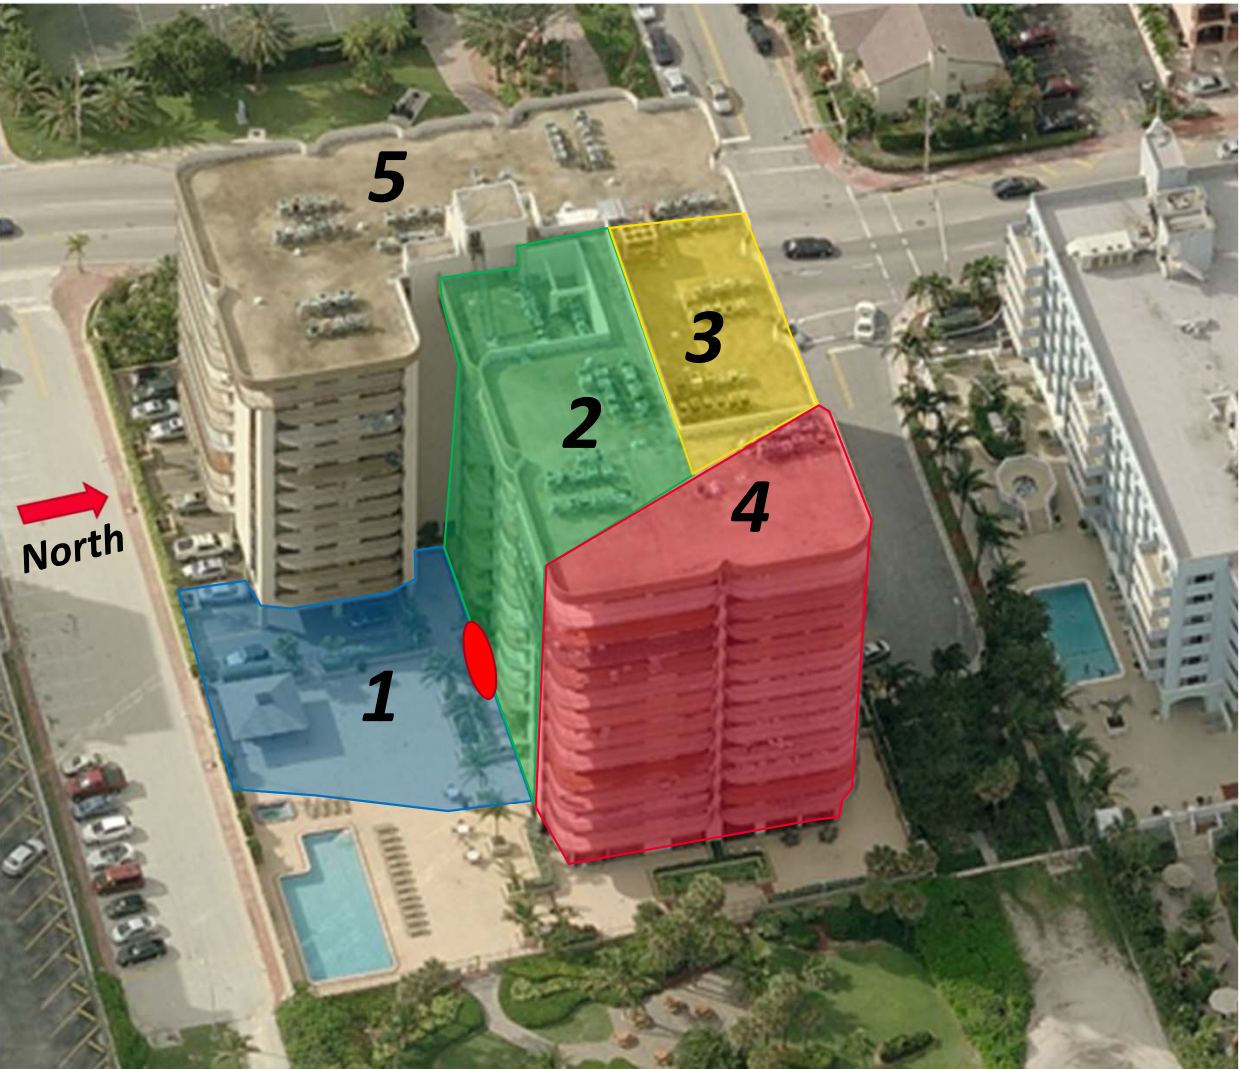
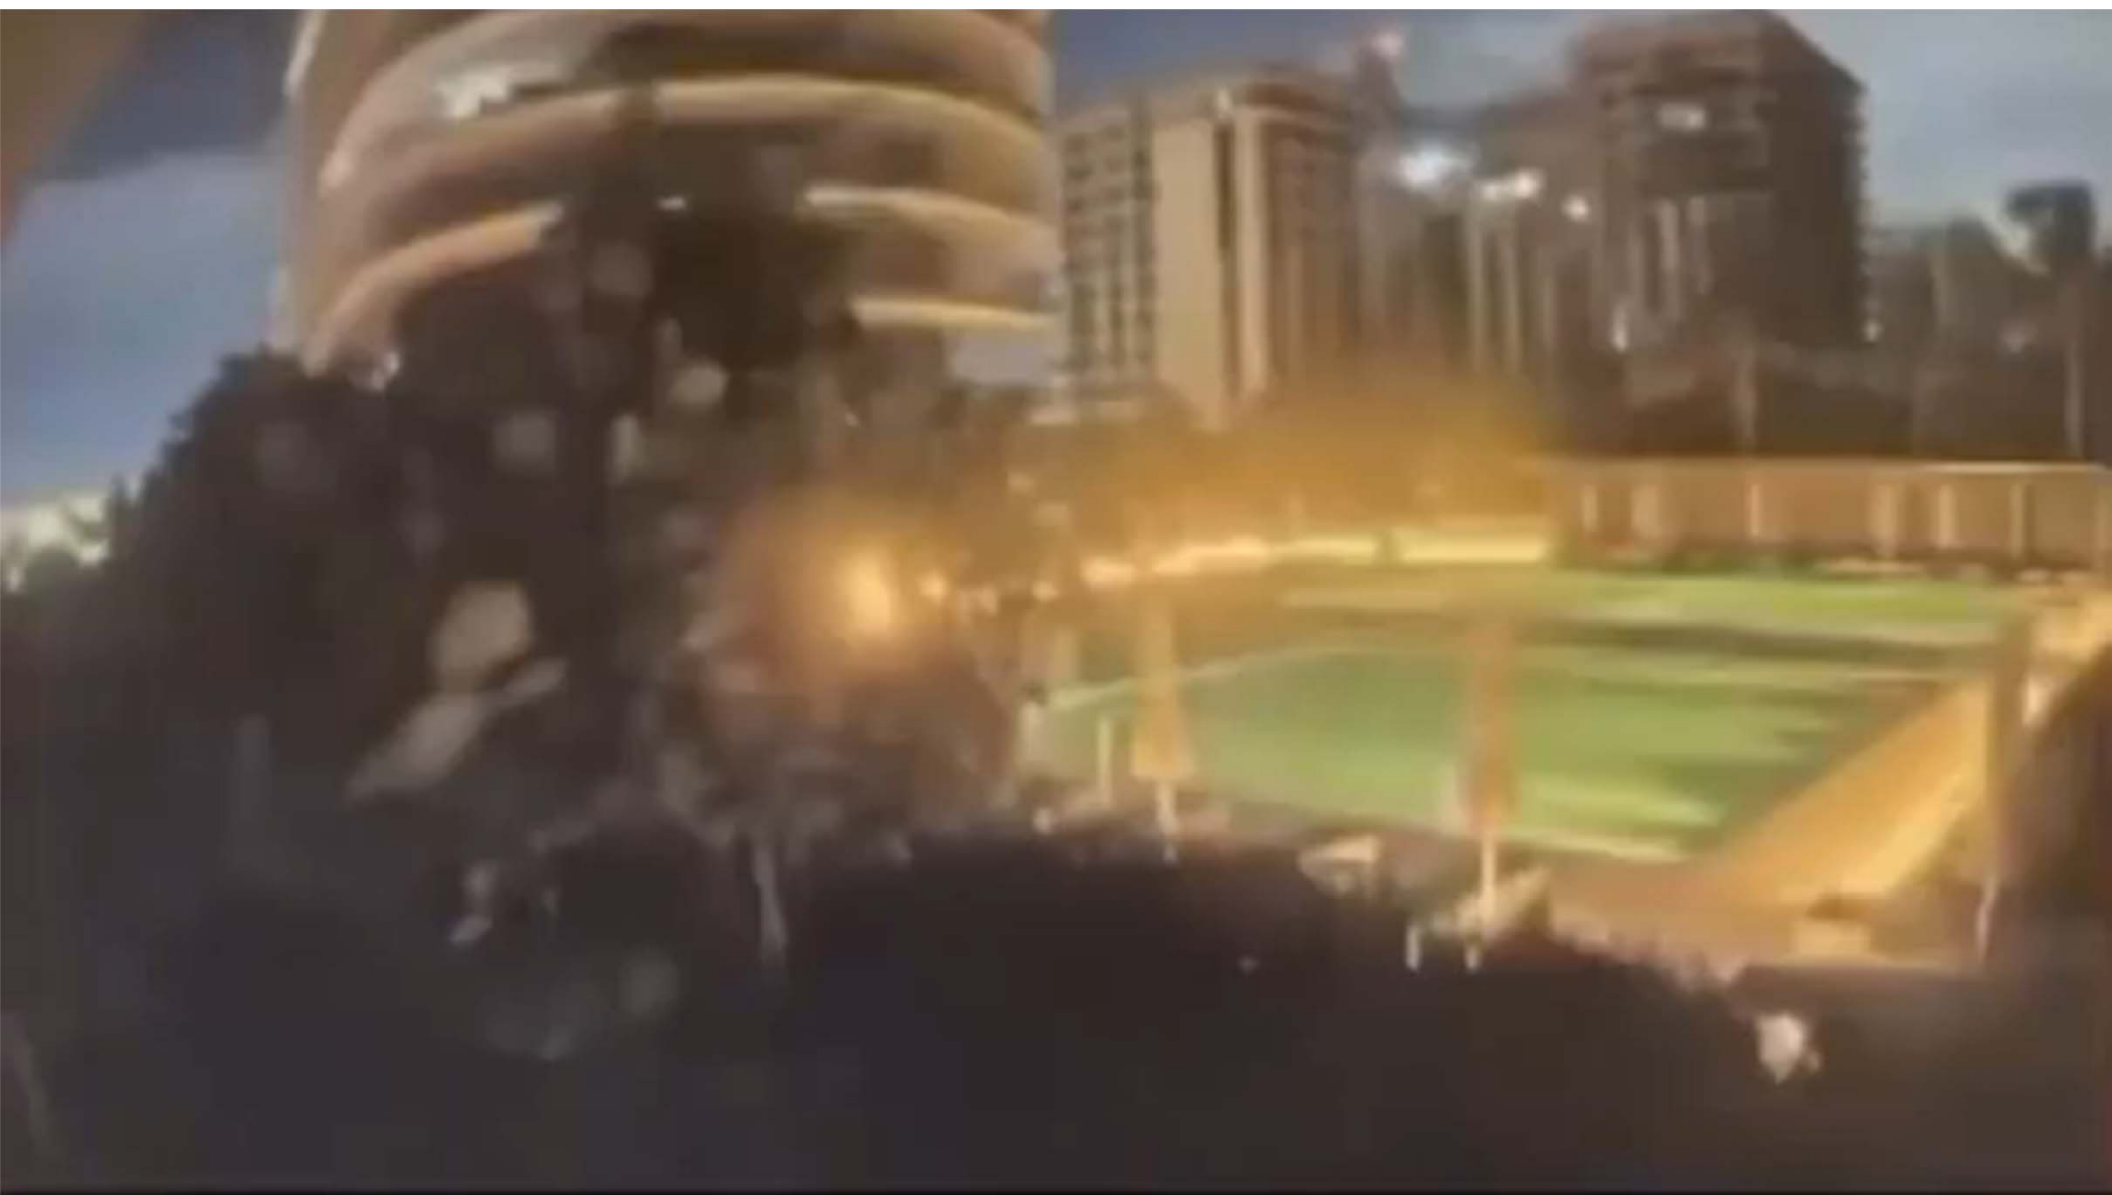
**Collapse Timeline**  
**June 24, 2021**

1	1:10– 1:15 AM	Pool Deck
7 – 12 minutes		
2	1:22 AM	East Tower South
3	+ 3 seconds	East Tower North
4	+ 8 seconds	East Tower East
5	West portion does not collapse

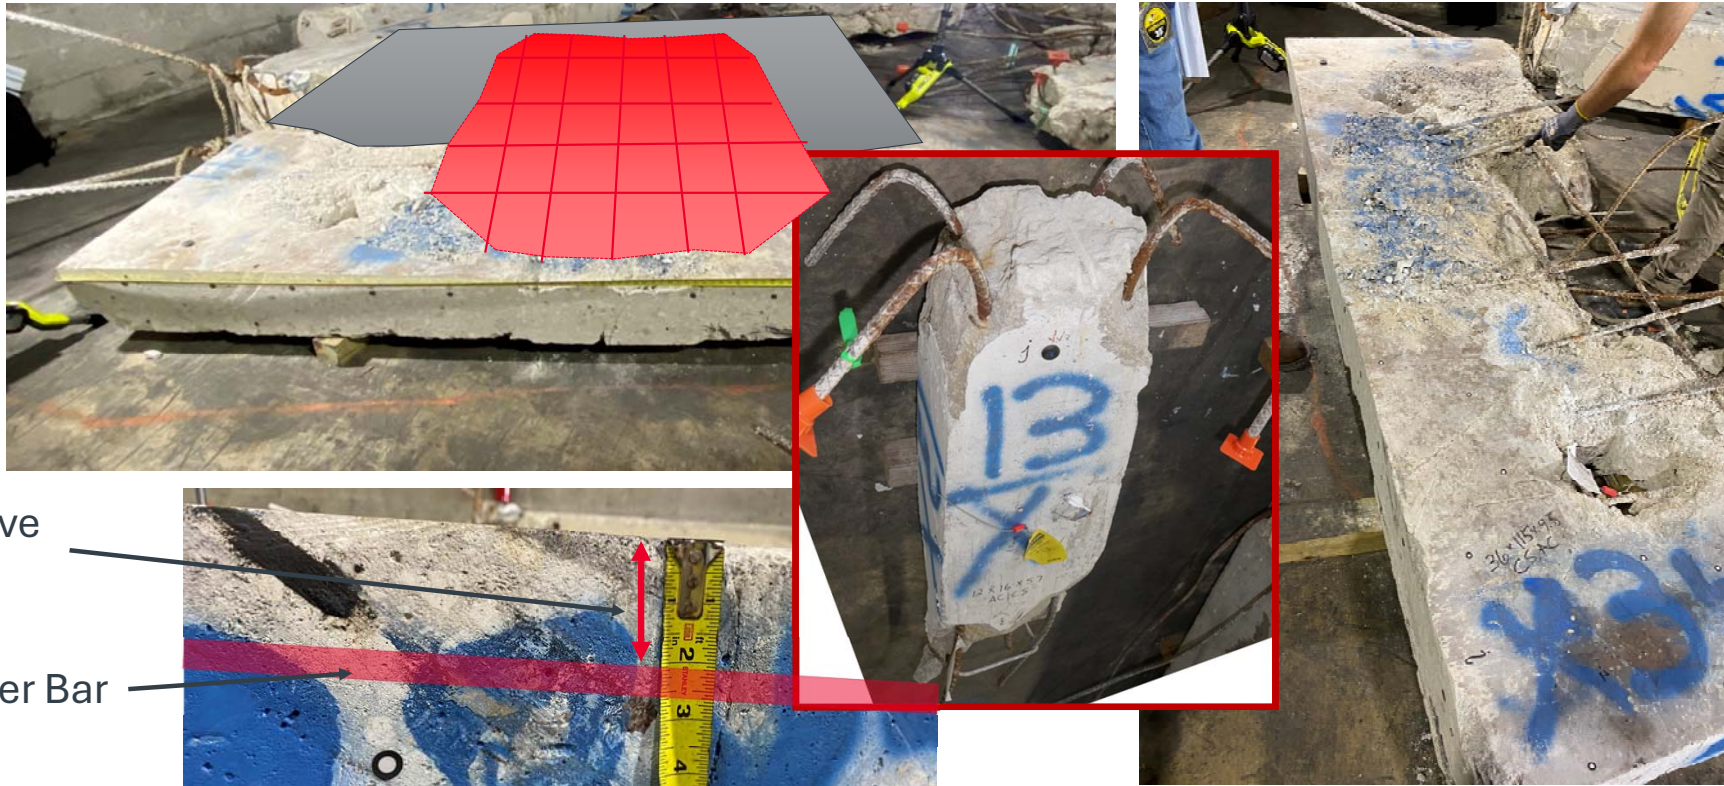
## Primary Evidence Facility – Item 344 "Punched Slab"

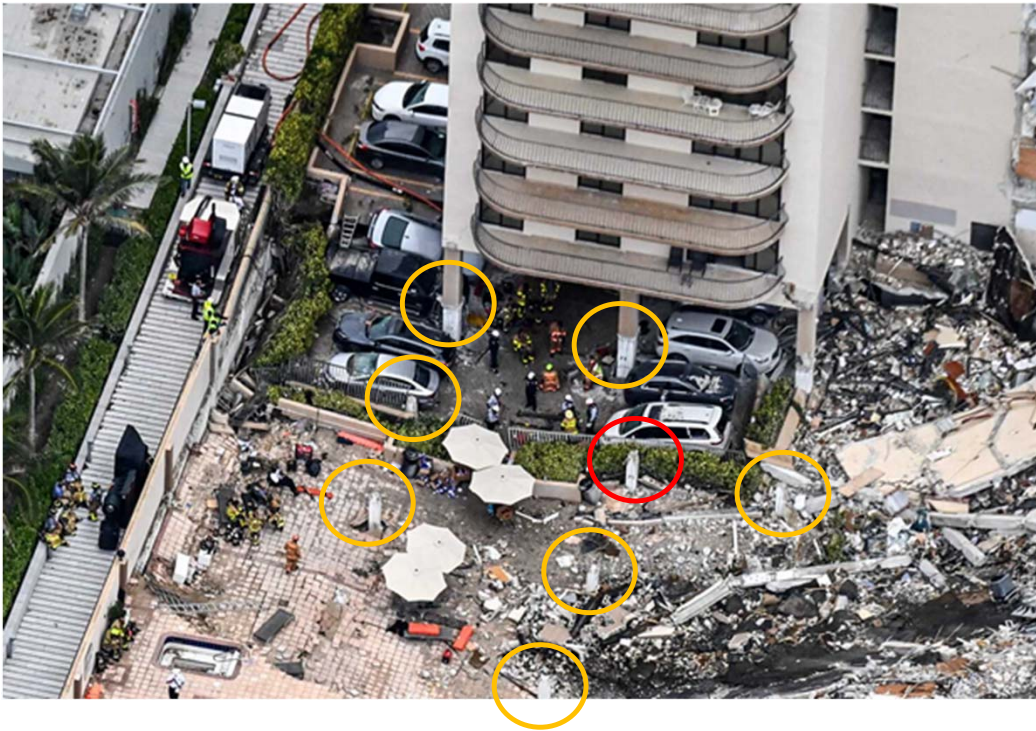
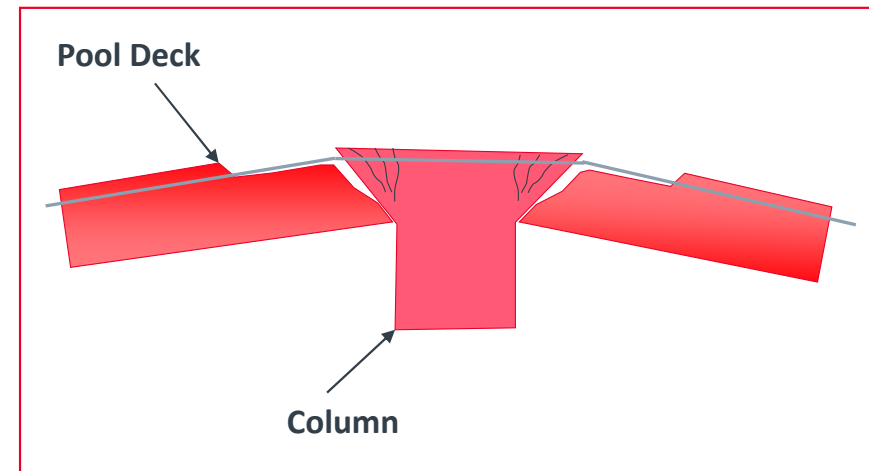
## Punching Shear Failures

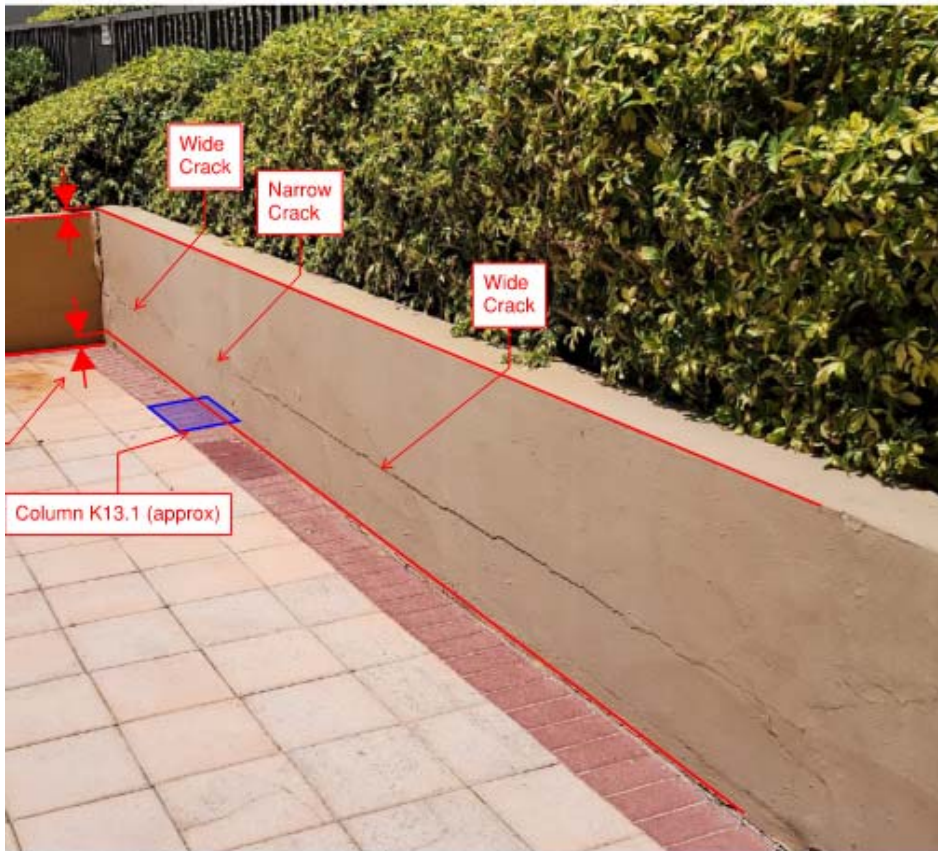
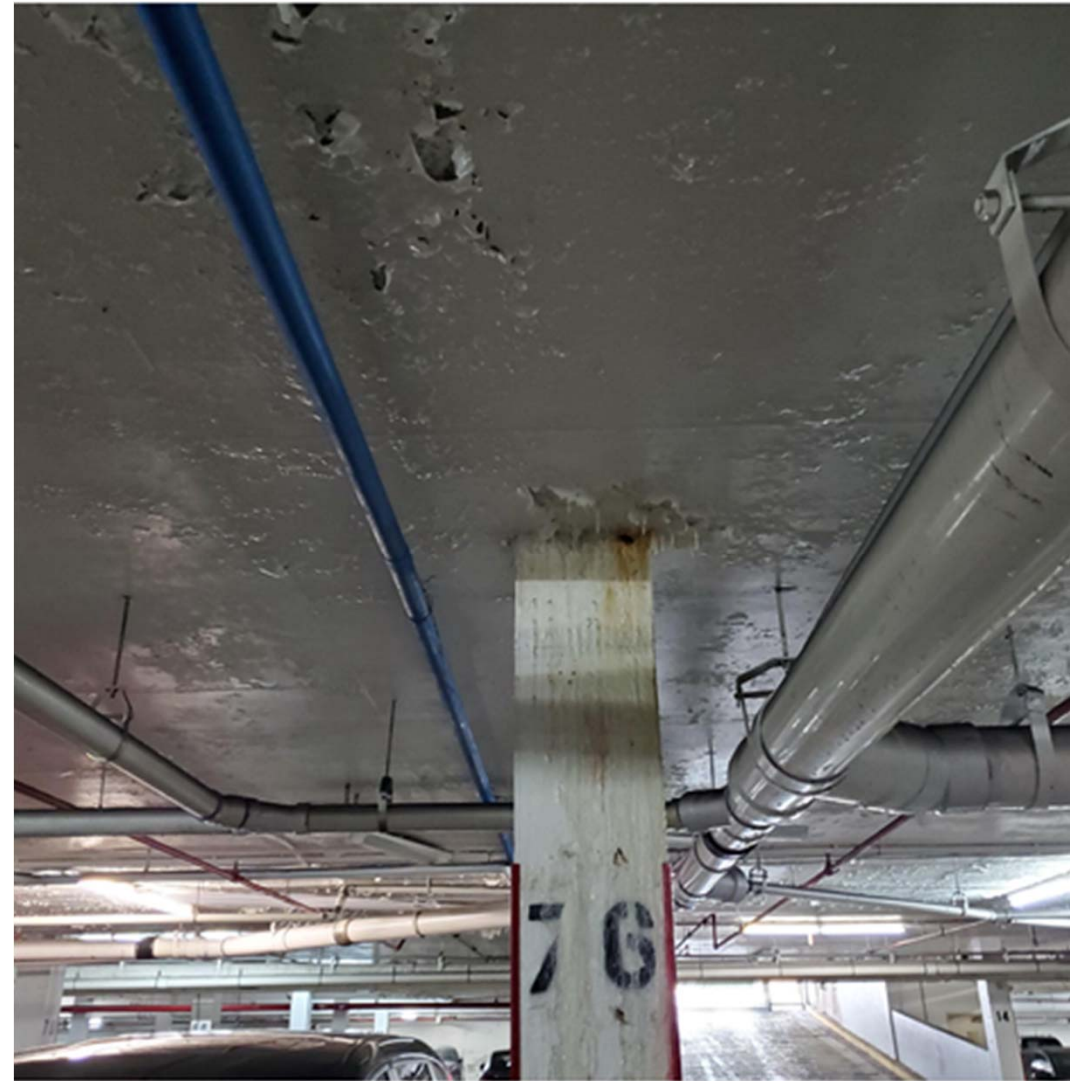
## Pool Deck Slab Distress

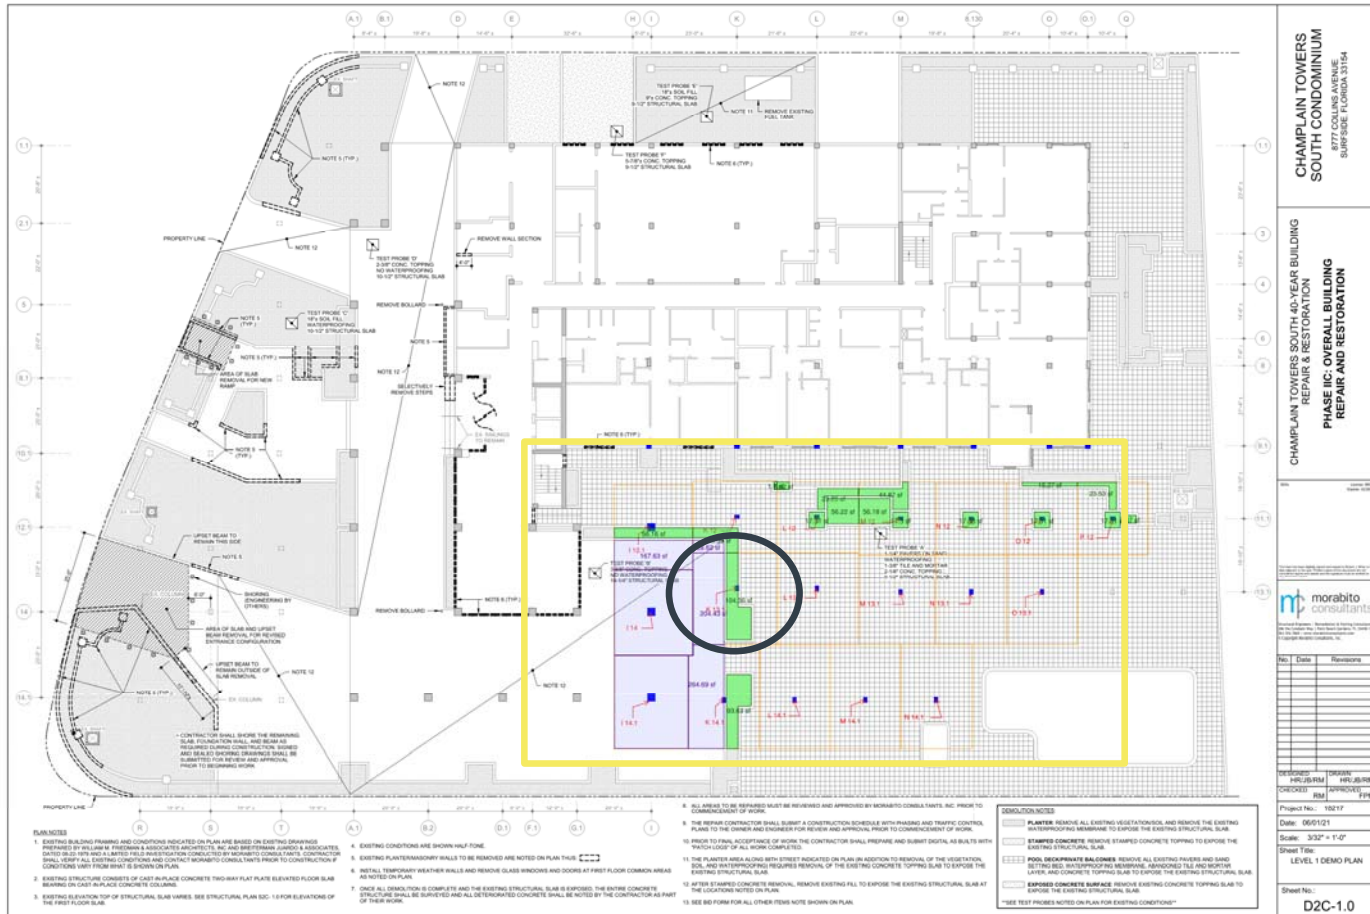
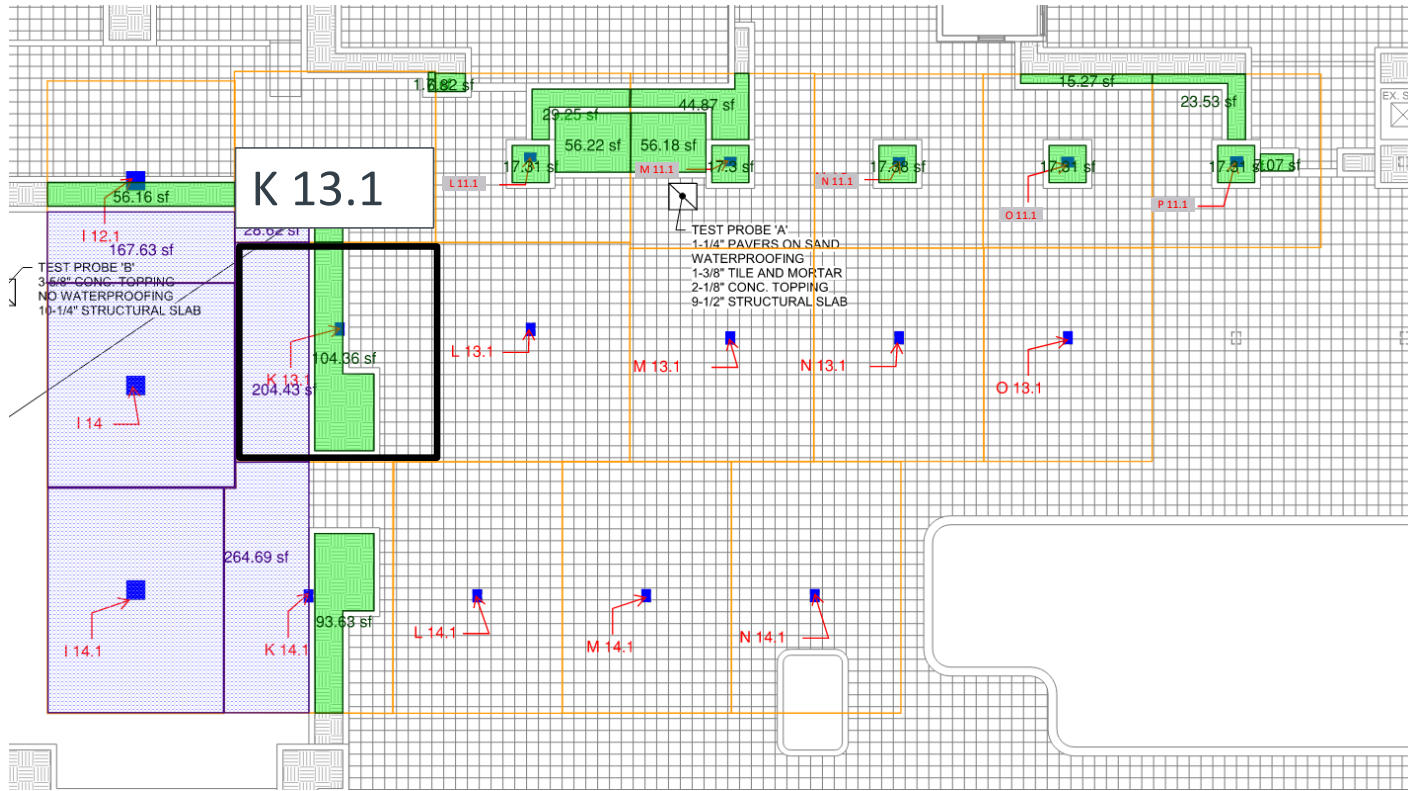
## Pool Deck Punching Shear (Column K 13.1)

As Designed (safety factor)	K 13.1
Size (in x in)	16x12
Nominal $f'_c$ (psi)	4000
Clear Cover (in)	0.75
Factored Load (kip)	266
Reduced Nominal Capacity (kip)	155
<b>Demand to Capacity Ratio</b>	<b>1.72</b>

At Collapse (no safety factor)	K 13.1
Size (in x in)	16x12
Estimated $f'_c$ (psi)	5000
Clear Cover (in)	2.13
Estimated Load (D) (kip)	128
Nominal Capacity (kip)	150
<b>Demand to Capacity Ratio</b>	<b>0.85</b>

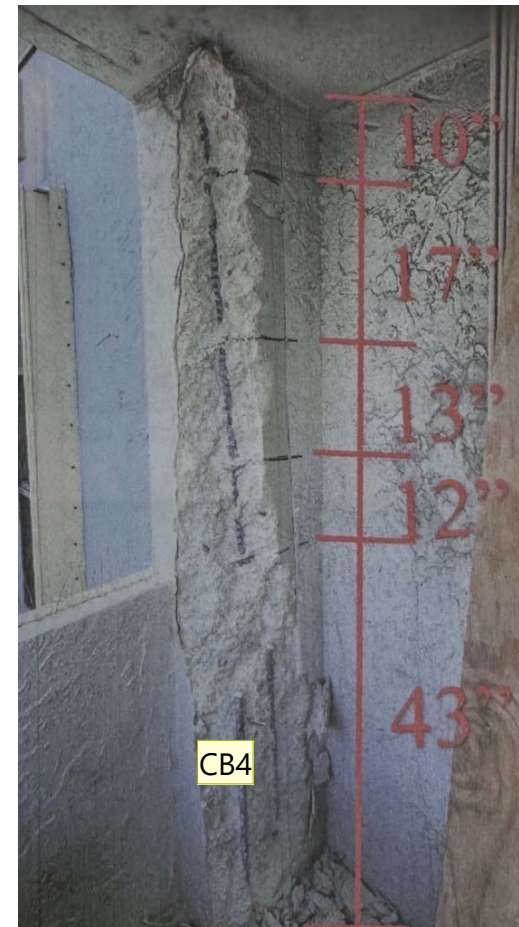
## Examples 2 - Late 1970s Building With Excessive Column Tie Spacing

- During extensive structural maintenance CB2 work related to an ongoing recertification
- Tie spacing in columns CB1 was found to be greater than the current code-prescribed minimums
  - Invasive and unsubstantiated investigation
- Engineer drafted a letter recommending conditional occupancy without a proper analysis or understanding of the significance CB3
- Column tie spacing has a minor effect on columns dominated by axial loads (<5% of capacity) CB4

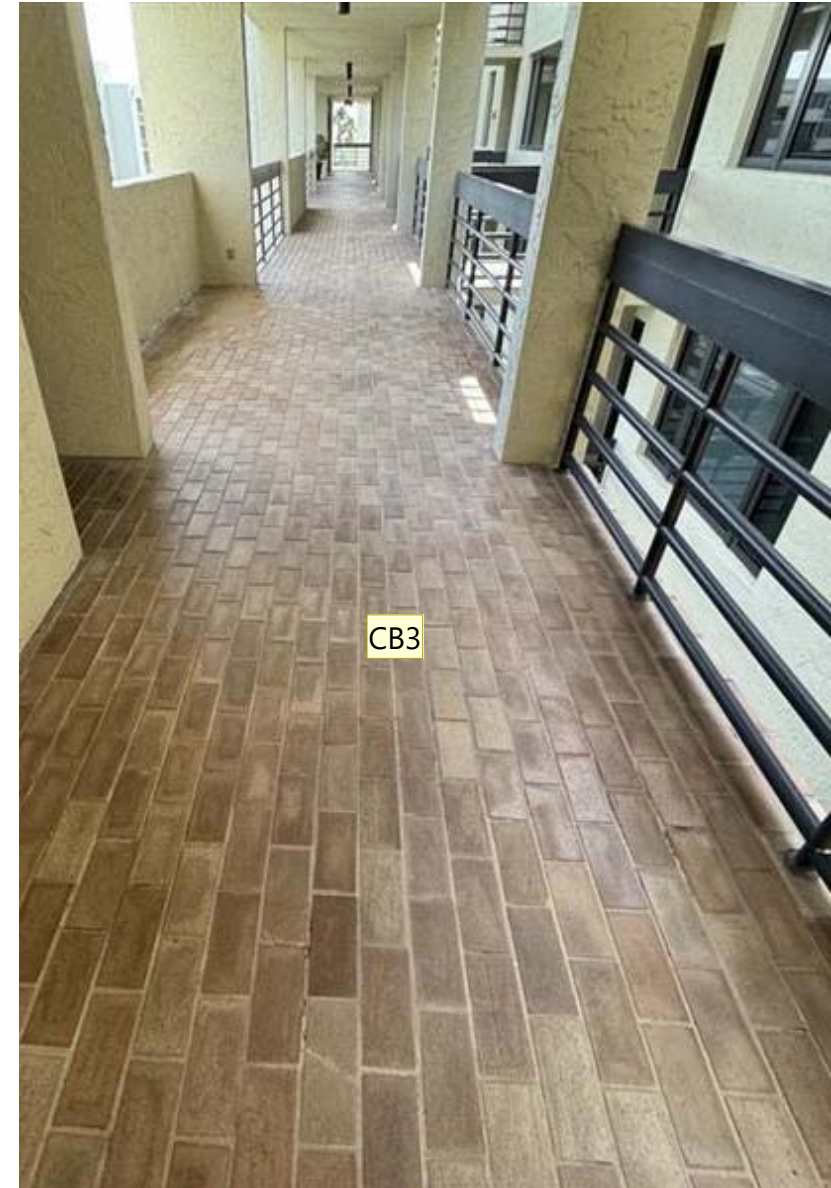
### Example 3 – Excessive Maintenance Level Upgrades

- 40-year assessment noted maintenance level distress; the engineer required \$ 30 M+ maintenance upgrades
  - No structural deficiencies, laboratory CB1 evaluation, or analysis conducted
- Engineers cannot mandate work
  - CB2 Waterproofing can alter the architectural characteristics
  - Significant upfront costs burden owners
  - Some owners may prefer architectural considerations over maintenance-level performance
