Florida Bar Construction Law Committee

Champlain Towers South Collapse Investigation

Matthew Fadden, PhD, PE

Gary Klein, PE, SE

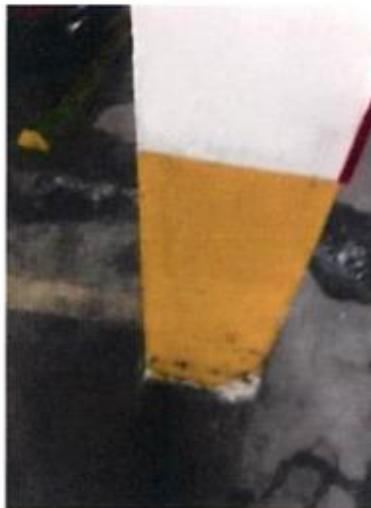
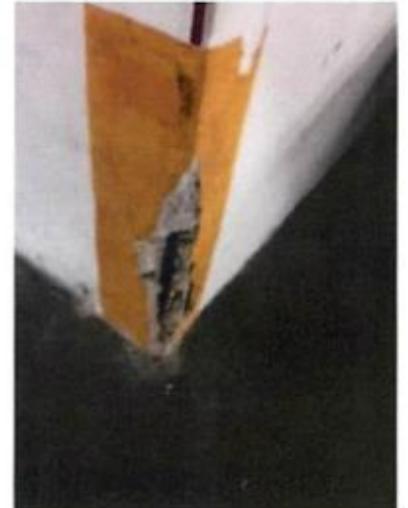
- Abundant cracking and spalling in garage with calcium carbonate leaching
- Previous repairs failing due to poor workmanship
- Concrete repair recommended following standard practices
- Recommend that the entrance and pool decks slabs showing distress be removed and replaced

Figure J1: Typical cracking and spalling at parking garage columns

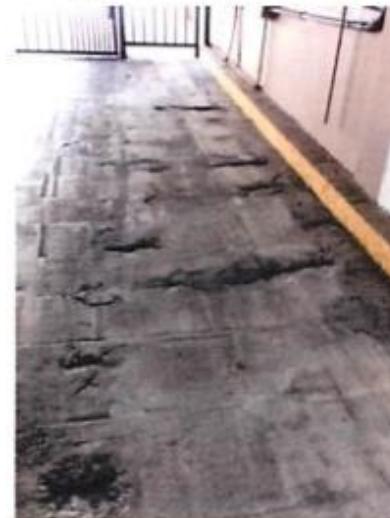
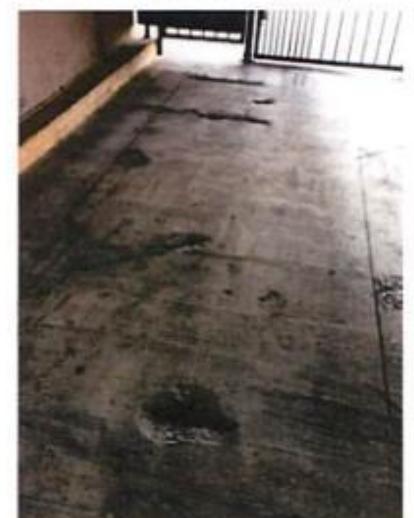
Figure J2: Spalling with exposed steel reinforcement at topside of garage deck.

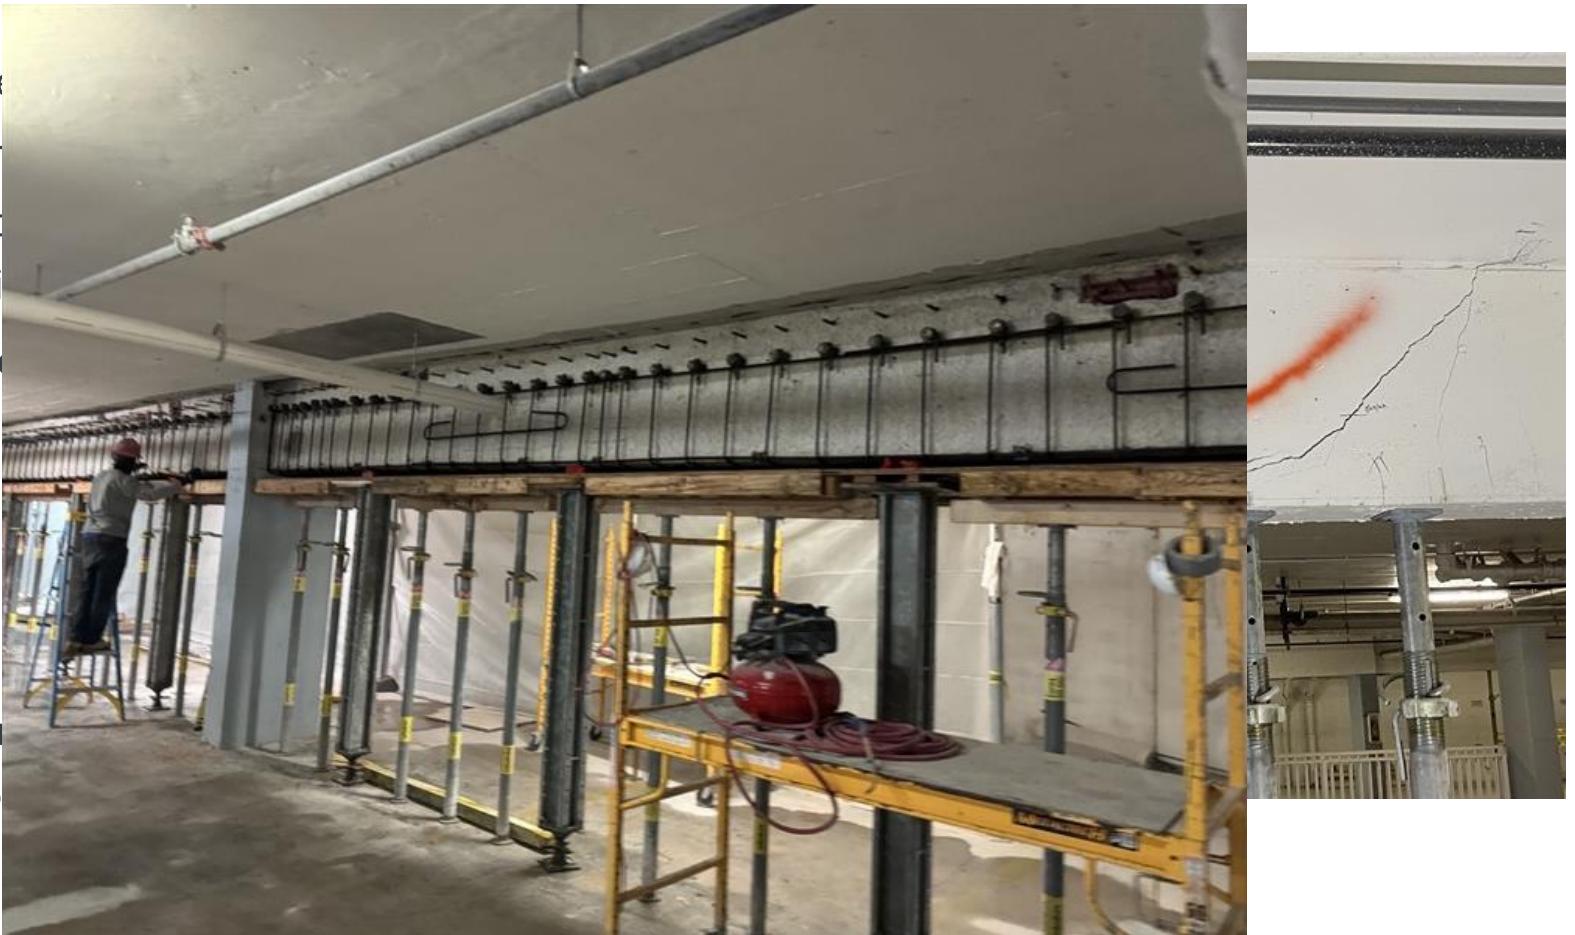
Example 1 - Early 1970's Beam With Shear Cracking

- Noted by engineer related to the 50-year-old beam:
 - Already carried out concrete repair
 - Original retained
- Engineer's letter issued during building evacuation:
 - No analysis or calculations
 - Displacement limit exceeded
- Association structural issue due to prior damage

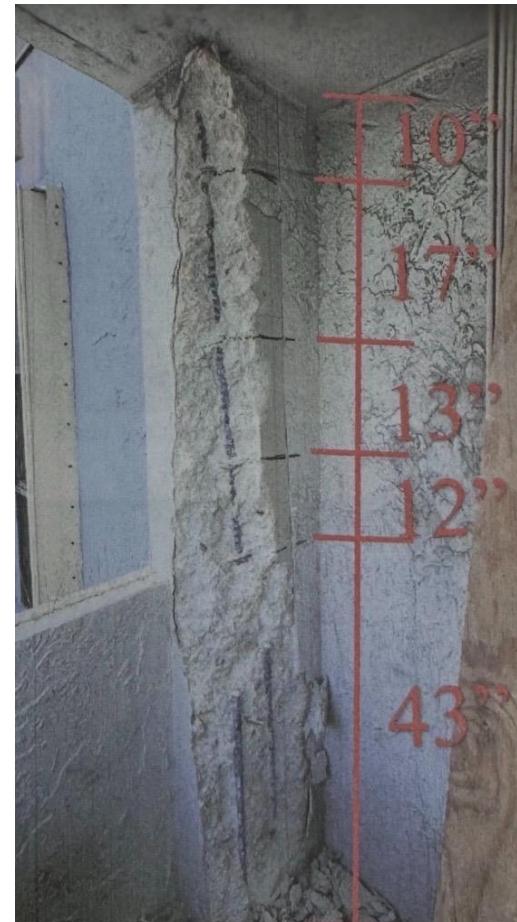
Examples 2 - Late 1970s Building With Excessive Column Tie Spacing

- During extensive structural maintenance work related to an ongoing recertification
- Tie spacing in columns was found to be greater than the current code-prescribed minimums
 - Invasive and unsubstantiated investigation
- Engineer drafted a letter recommending conditional occupancy without a proper analysis or understanding of the significance
- Column tie spacing has a minor effect on columns dominated by axial loads (<5% of capacity)

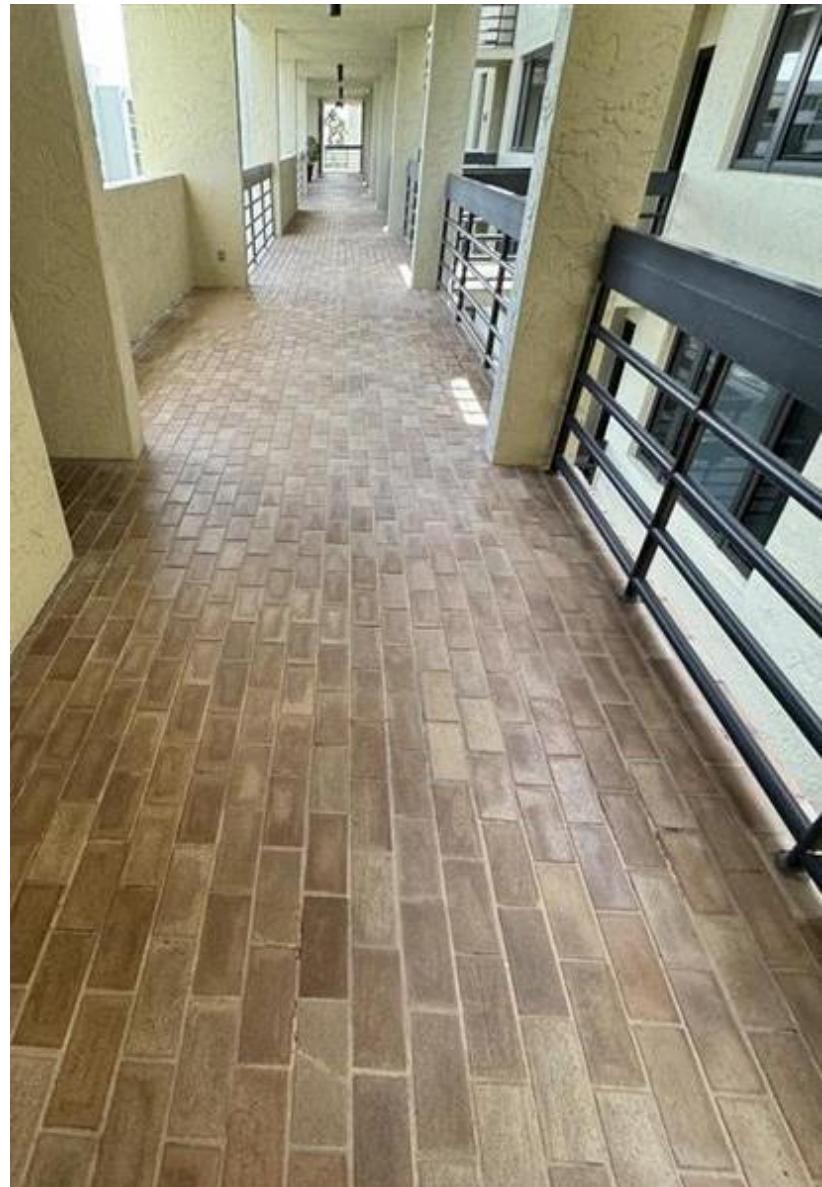
Example 3 – Excessive Maintenance Level Upgrades

- 40-year assessment noted maintenance level distress; the engineer recommend \$ 30 M+ maintenance upgrades
 - No structural deficiencies, laboratory evaluation, or analysis conducted
- Engineers should inform client of options
 - Waterproofing can alter the architectural characteristics
 - Significant upfront costs burden owners
 - Some owners may prefer architectural considerations over maintenance-level performance
