**CLE Presentation  
to the Construction  
Law Committee  
October 12, 2015**

## CONSTRUCTION DEFECT CASE STUDY USING A JOINT DEFENSE

**Jack MacGiffert, CCM, PMP, CIEC, LEED-AP**  
**Hill International, Inc.**

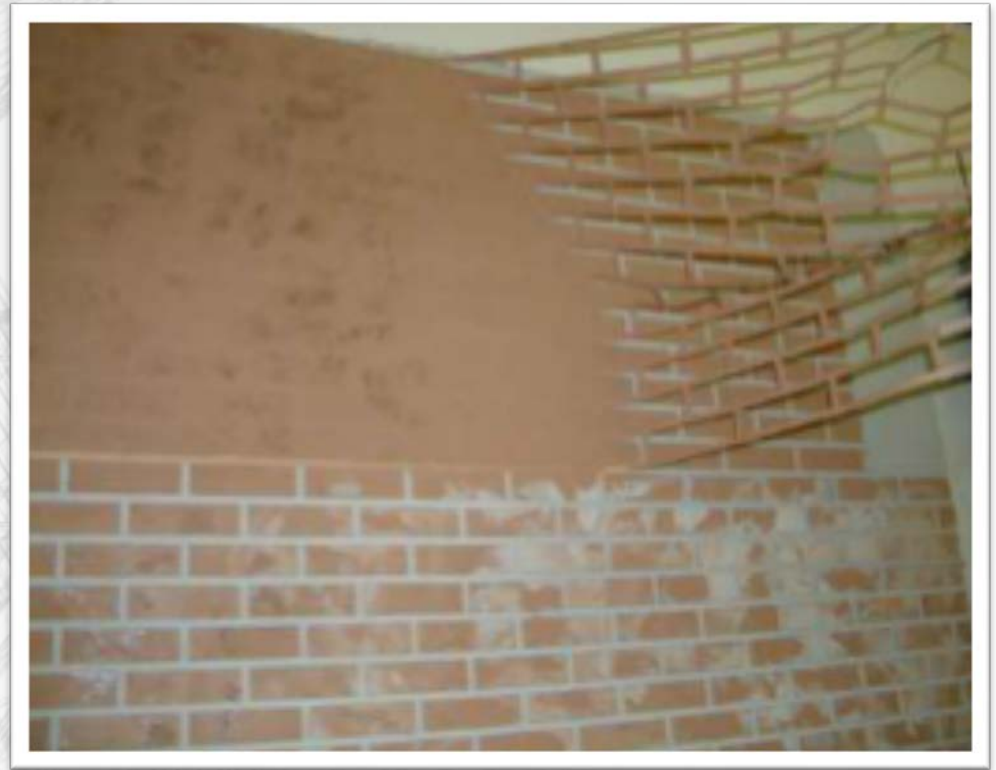
## PRIMARY DAMAGE ISSUE - WATER INTRUSION

- Pre Con - VE - Changes the exterior façade from ACTUAL brick to faux brick
- Architect does not take advice from his own pre construction waterproofing expert.
- Architect ignores details and insists system be installed as barrier system (SYSTEM IS NOT A BARRIER SYSTEM)
