# Champlain Towers South Collapse Investigation

Matthew Fadden, PhD, PE  
*Managing Director and Principal  
Walter P Moore Associates, Inc.*

Gary Klein, PE, SE  
*Vice President and Senior Principal  
Wiss, Janney, Elstner Associates, Inc.*

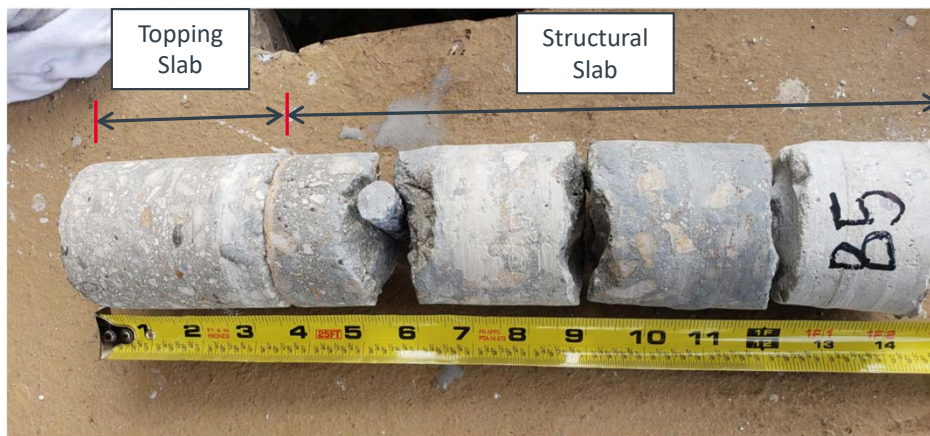
Parking Deck

Excessive Cover

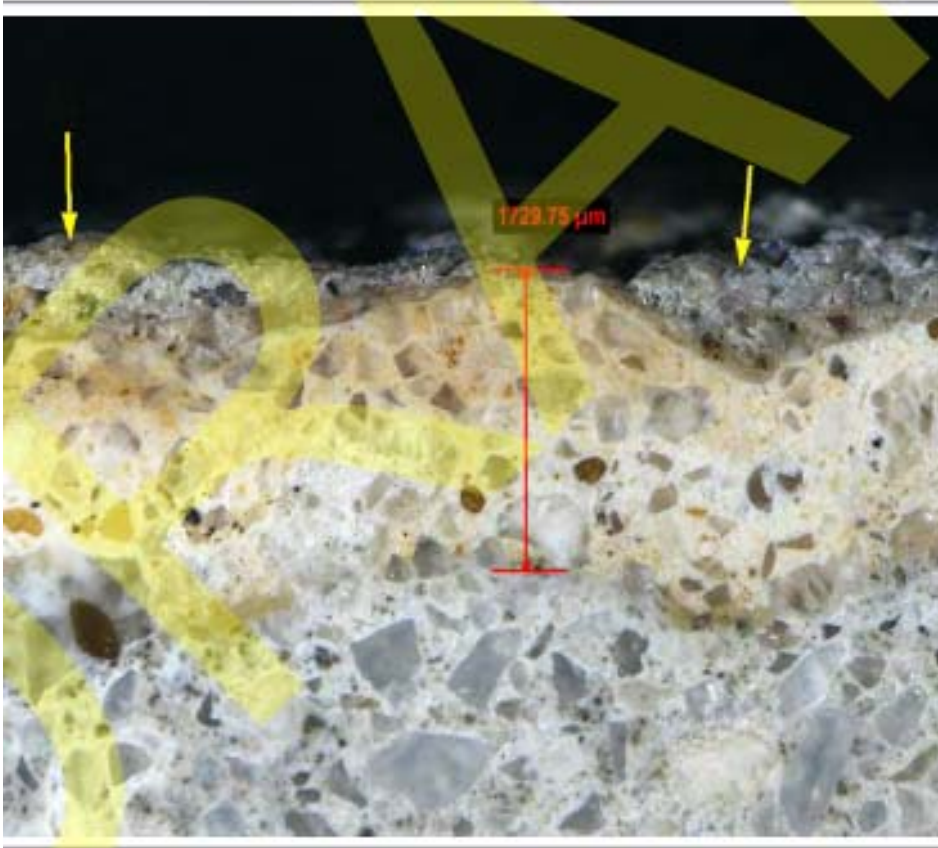
## Concrete Petrography and Testing

- Concrete typical to Florida
  - Moderate w/c ratio (0.35-0.45)
  - Well mixed
  - Non-air entrained
- Corrosion consistent with that at concrete placement
- Low chlorides and carbonation

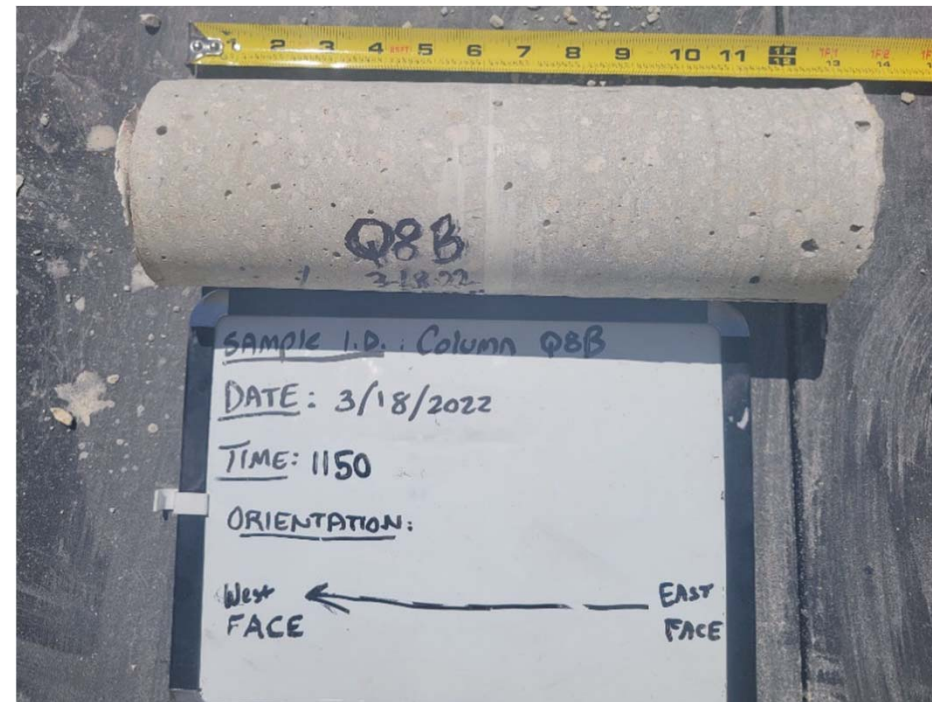
## Concrete Material Properties

Location	Average Compressive Strength psi (MPa)	Min. Specified Compressive Strength psi (MPa)
Transfer Girder	3560 (25)	4000 (28)
Column M15.1	3785 (26)	6000 (41)
Column Q8	5820 (40)	6000 (41)
Pool Deck	4475 (31)	4000 (28)
Perimeter Wall	4280 (30)	4000 (28)
Shear Wall East	6600 (46)	6000 (41)
Shear Wall West	8155 (56)	6000 (41)

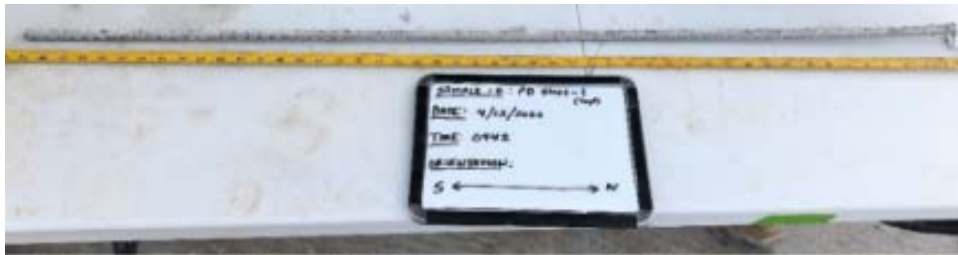
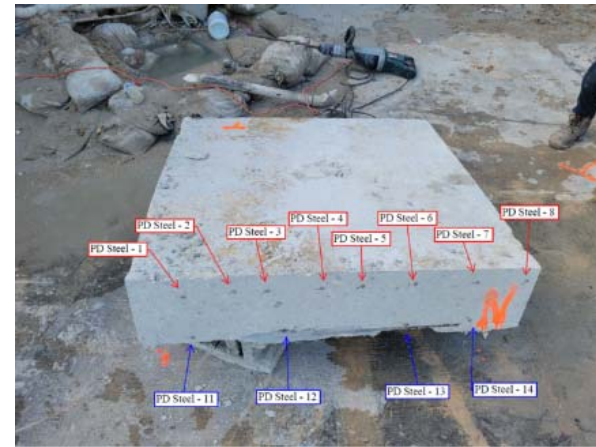
## Steel Reinforcement

Min. Specified (ASTM 615 Gr. 60)	Perimeter Wall (avg.)	Pool Deck (avg.)
Yield – $F_y$ : psi (MPa)	60,000 (414)	69,948 (482)	77,012 (531)
Ultimate – $F_u$ : psi (MPa)	90,000 (621)	106,814 (736)	110,300 (760)
Elongation (%)	7-9 depending on bar size	12.4	12.9

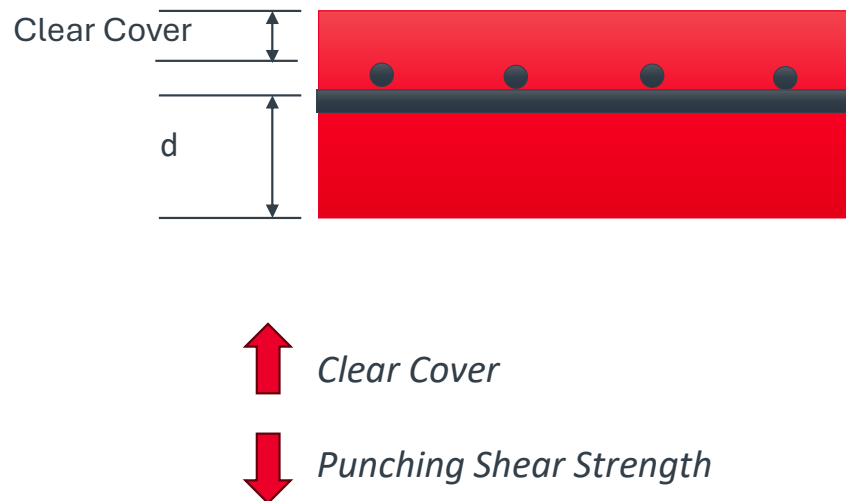
# Punching Shear

- Punching Shear
  - Dependent on slab depth and concrete strength
  - $V_c = 4\sqrt{f'_c}b_o d$
- Current research shows that:
  - Dependent on flexural reinforcement and slab thickness
  - A coefficient of 4 may be unconservative for low reinforcement ratios

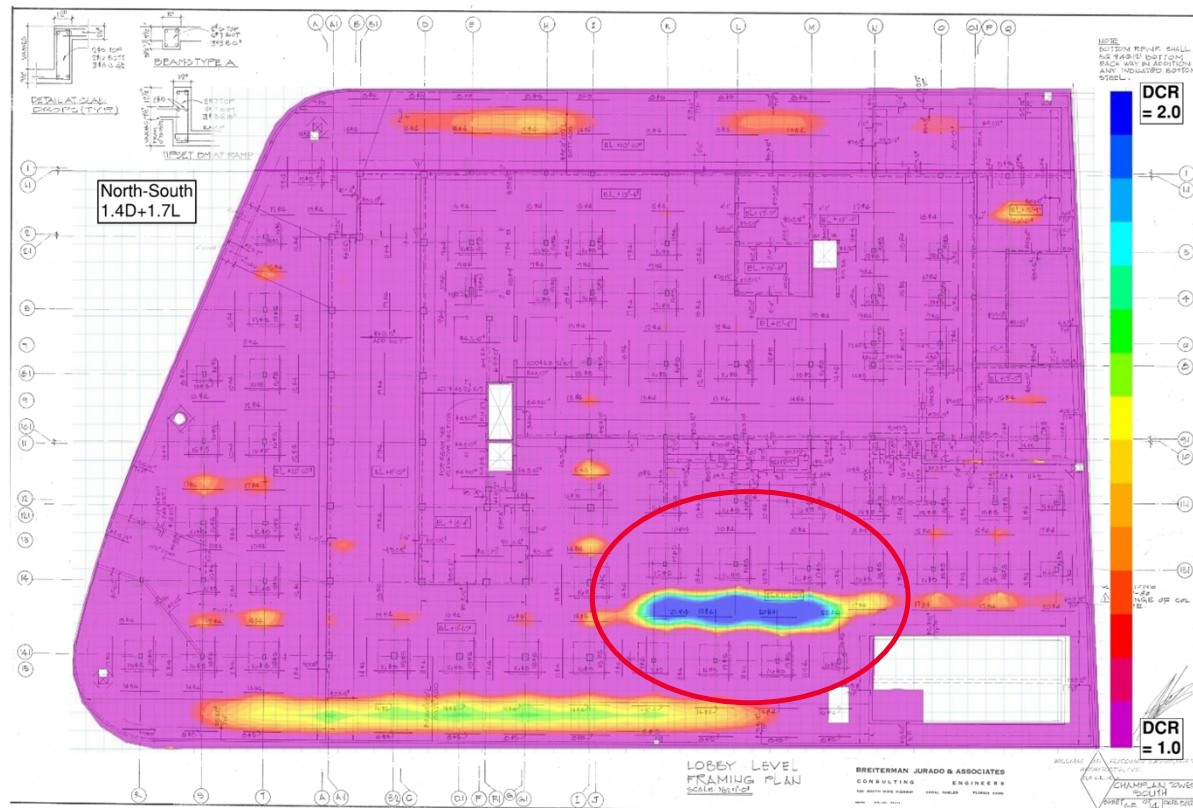
# Lobby Level Slab – Finite Element Model

As-Designed Positive Bending,  $1.4D+1.7L$ ,  $\Phi = 0.85$

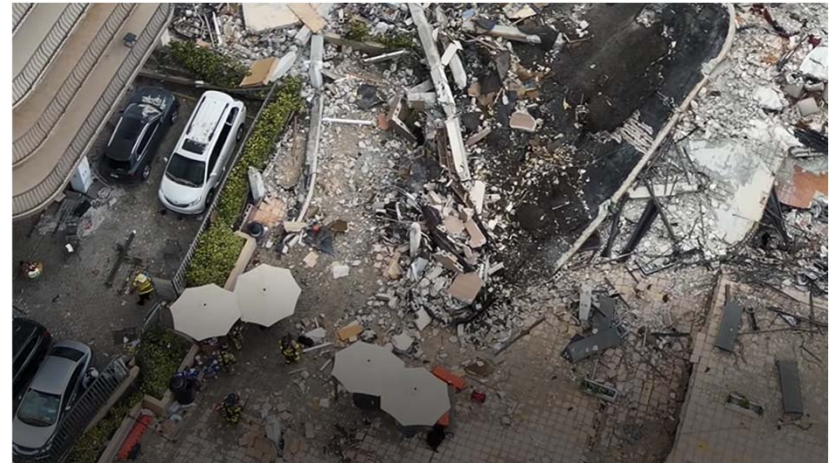
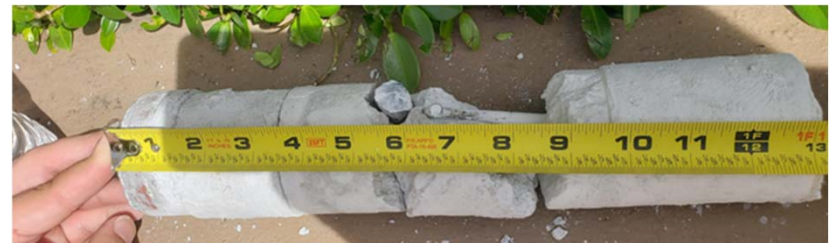
## Other Potential Contributing Causes

- Long-term sustained load effects
- Low top flexural reinforcement ratio
  - Code now requires more reinforcement
- Significance unclear
  - Water buildup in planters
  - Corrosion
