Florida Bar Construction Law Committee

Champlain Towers South Collapse Investigation

Matthew Fadden, PhD, PE

Gary Klein, PE, SE

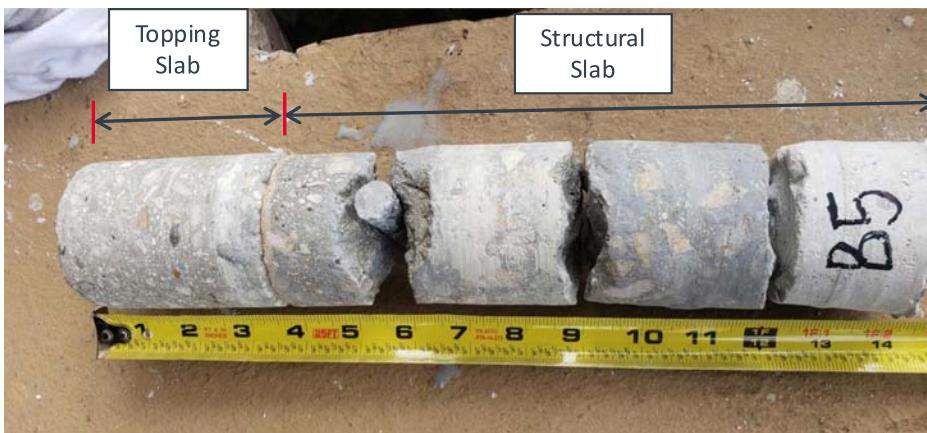
Parking Deck

Recertification Investigation – Concrete Core Samples

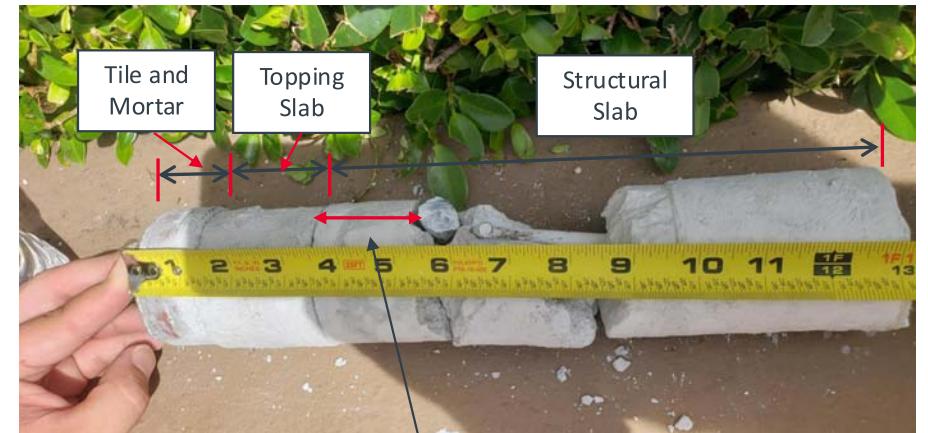
Pool Deck

Excessive Cover

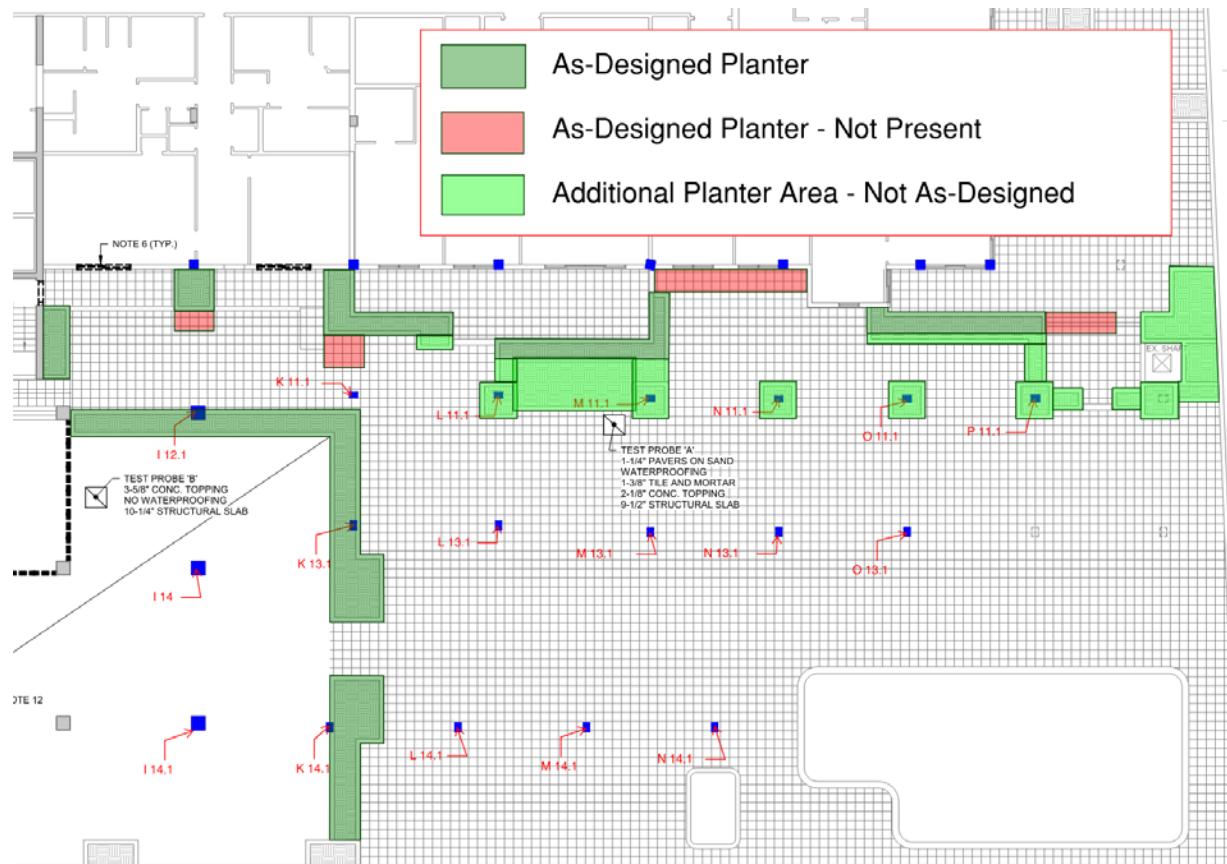
Recertification Investigation - Planters

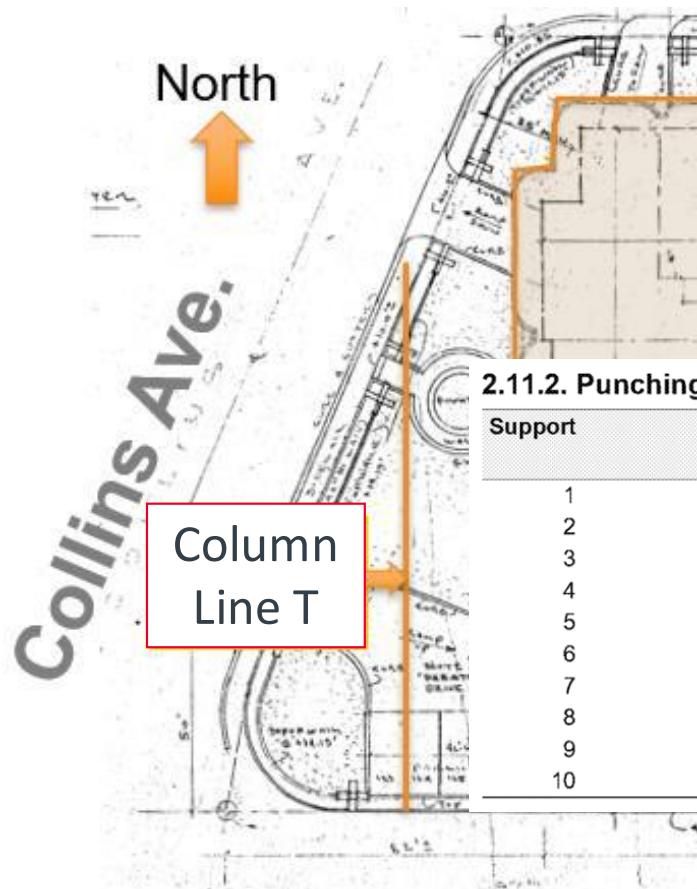
Recertification Engineer Calculations

2.11.2. Punching Shear Results

Support	V_u kip	v_u psi	M_{unb} k-ft	Comb	Patt	γ_v	v_u psi	ϕV_c psi
1	80.05	31.9	195.51	U1	All	0.117	343.7	101.5 *EXCEEDED
2	202.56	236.6	10.47	U1	All	0.415	244.8	189.7 *EXCEEDED
3	133.15	183.2	-39.19	U1	All	0.422	217.6	189.7 *EXCEEDED
4	164.83	192.5	12.83	U1	All	0.375	200.5	189.7 *EXCEEDED
5	176.45	206.1	-18.39	U1	All	0.415	217.8	189.7 *EXCEEDED
6	133.61	183.9	6.98	U1	All	0.422	190.0	189.7 *EXCEEDED
7	156.94	216.0	6.70	U1	All	0.422	221.8	189.7 *EXCEEDED
8	146.79	171.5	-25.71	U1	All	0.375	191.2	189.7 *EXCEEDED
9	178.11	180.7	16.77	U1	All	0.380	190.3	189.7 *EXCEEDED
10	77.04	30.7	-172.04	U1	All	0.117	299.8	101.5 *EXCEEDED

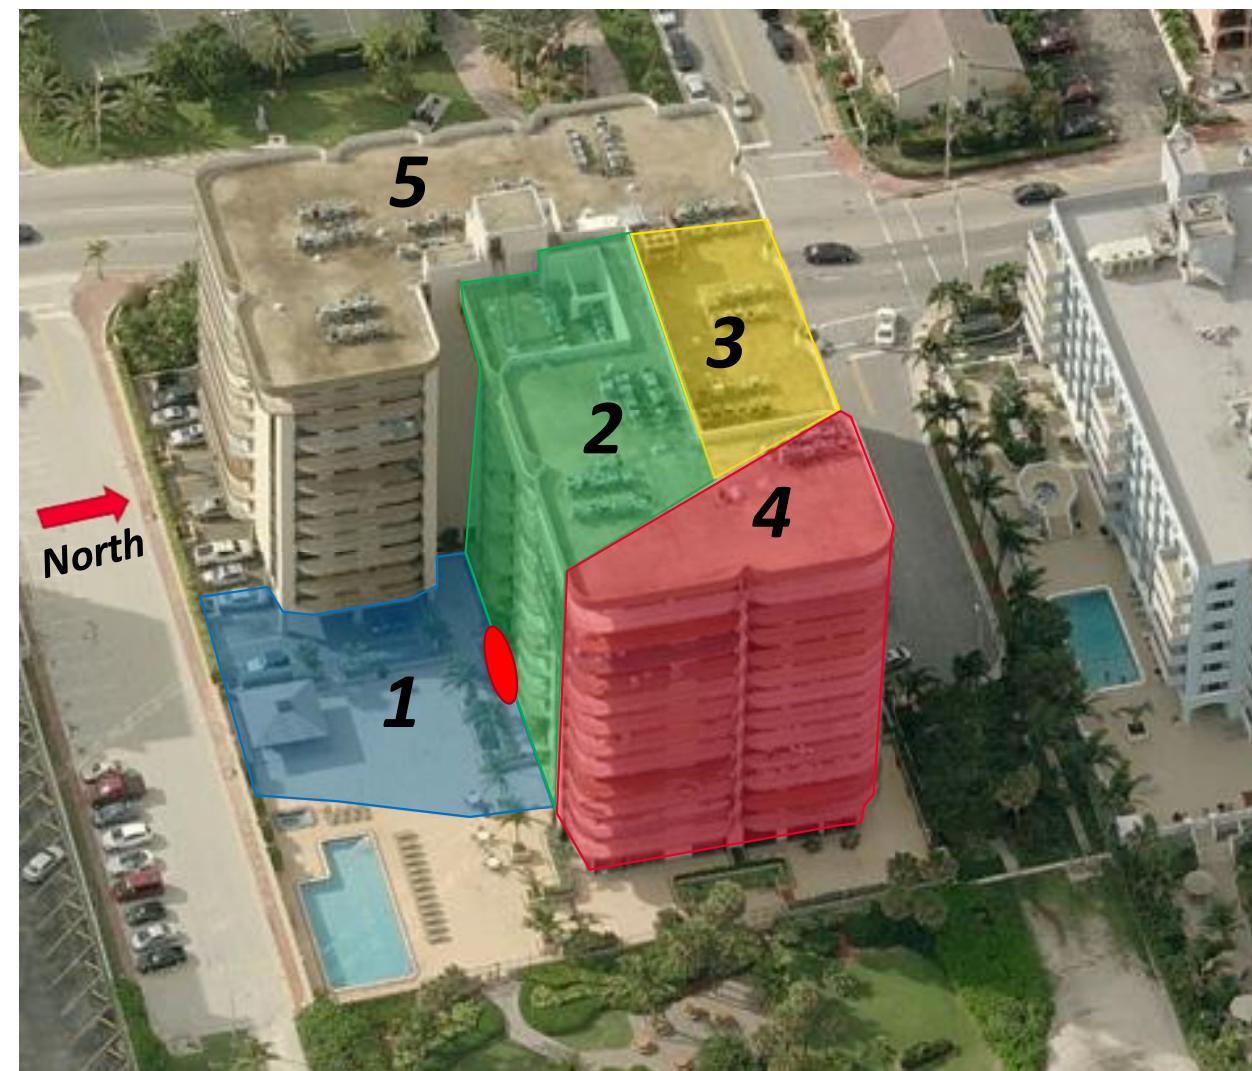
Unit 711

Ring Video

Unit 611

Cracks in Walls

Unit 111

12:30 am:
Construction Noises
1:10-1:15 am:
Pool Deck Collapse

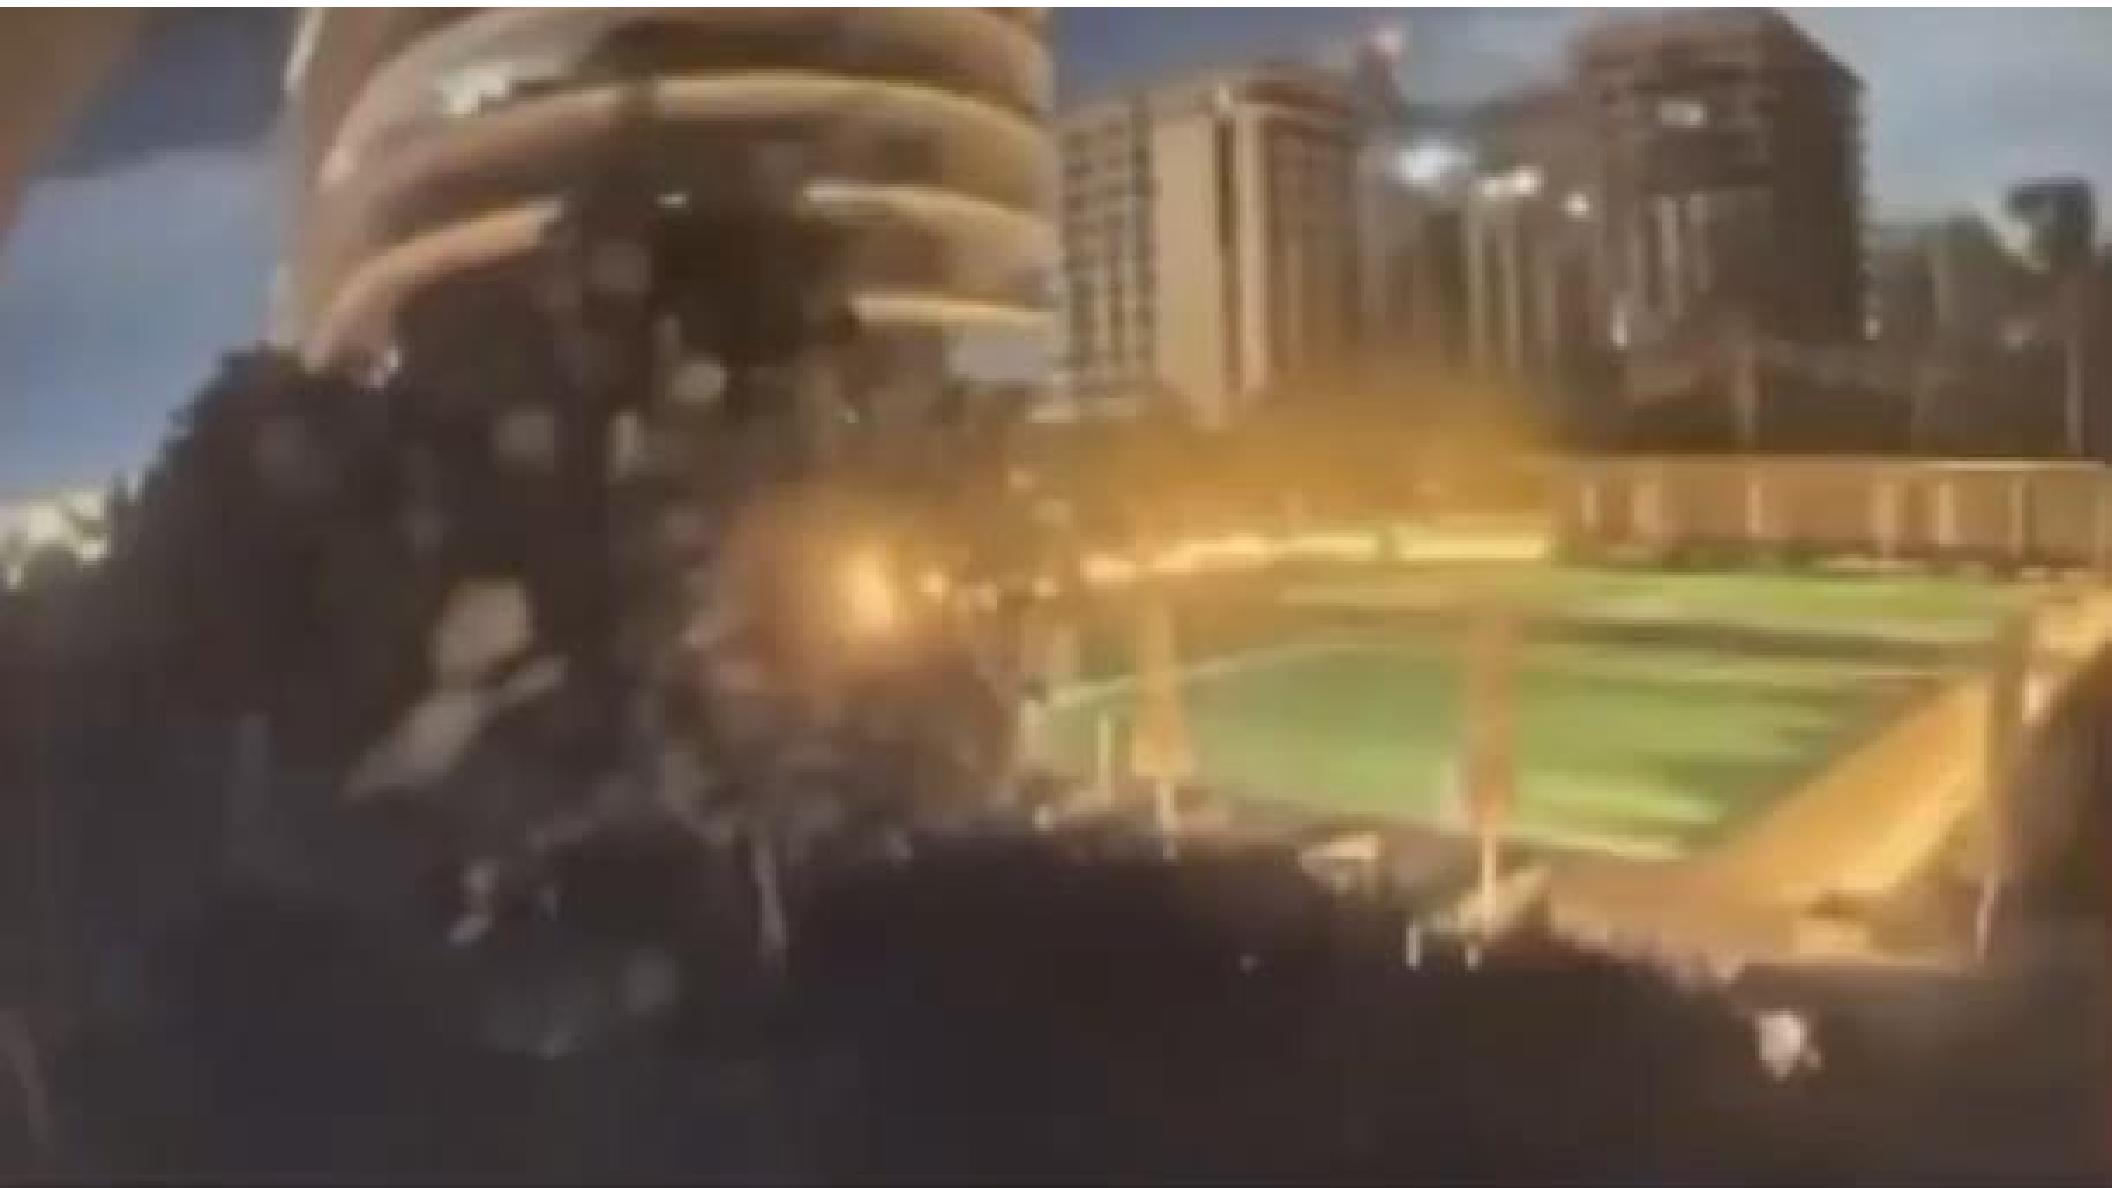
Collapse Timeline June 24, 2021

1	1:10– 1:15 AM	Pool Deck
7 – 12 minutes		
2	1:22 AM	East Tower South
3	+ 3 seconds	East Tower North
4	+ 8 seconds	East Tower East
5	West portion does not collapse

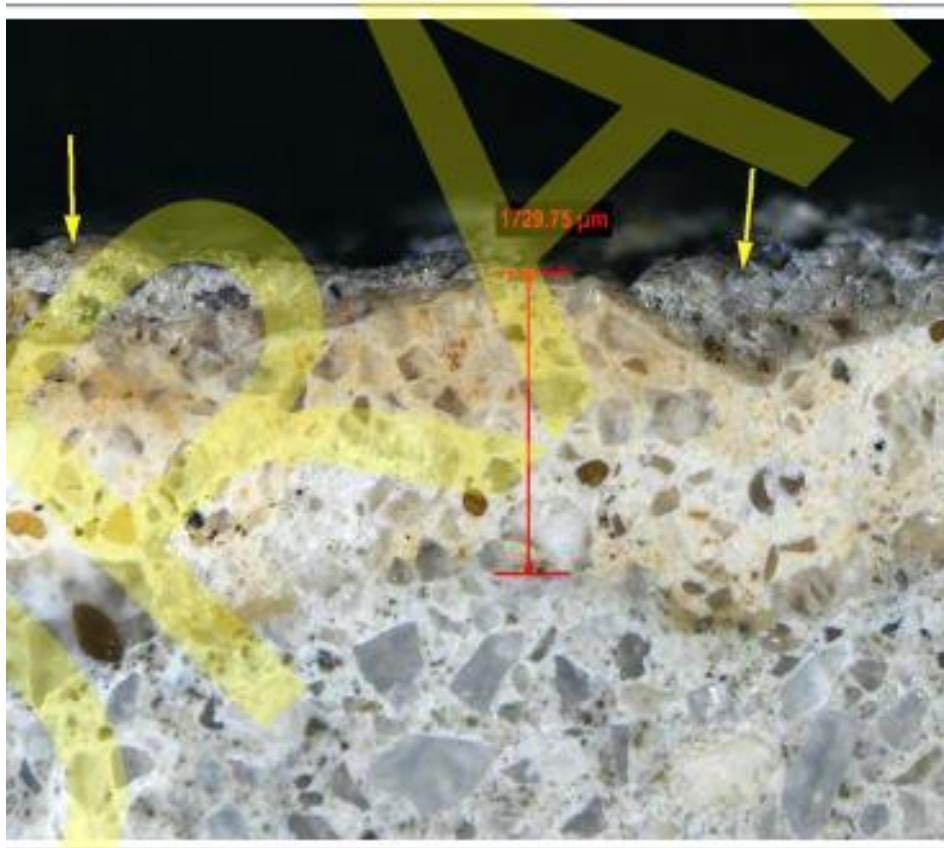
Basement Slab Samples

- Concrete typical to Florida
 - Moderate w/c ratio (0.35-0.45)
 - Well mixed
 - Non-air entrained
- Corrosion consistent with that at concrete placement
- Low chlorides and carbonation

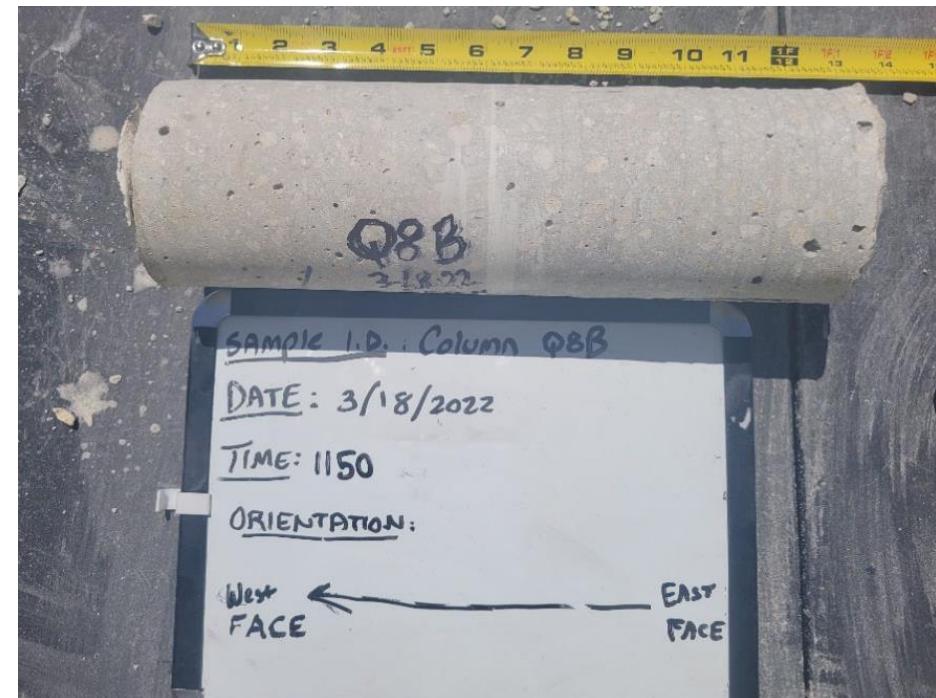
Concrete Material Properties

Location	Average Compressive Strength psi (MPa)	Min. Specified Compressive Strength psi (MPa)
Transfer Girder	3560 (25)	4000 (28)
Column M15.1	3785 (26)	6000 (41)
Column Q8	5820 (40)	6000 (41)
Pool Deck	4475 (31)	4000 (28)
Perimeter Wall	4280 (30)	4000 (28)
Shear Wall East	6600 (46)	6000 (41)
Shear Wall West	8155 (56)	6000 (41)

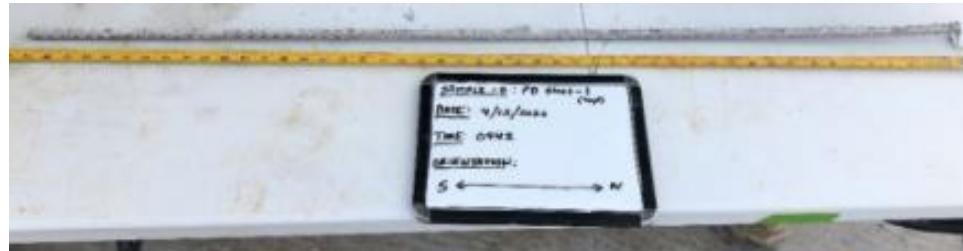
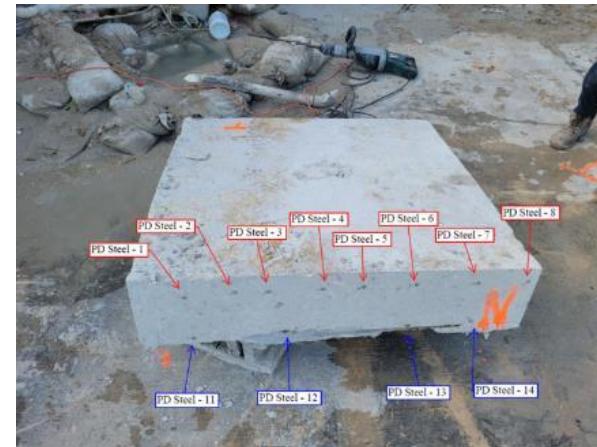
Steel Reinforcement

Min. Specified (ASTM 615 Gr. 60)	Perimeter Wall (avg.)	Pool Deck (avg.)
Yield – F_y : psi (MPa)	60,000 (414)	69,948 (482)	77,012 (531)
Ultimate – F_u : psi (MPa)	90,000 (621)	106,814 (736)	110,300 (760)
Elongation (%)	7-9 depending on bar size	12.4	12.9

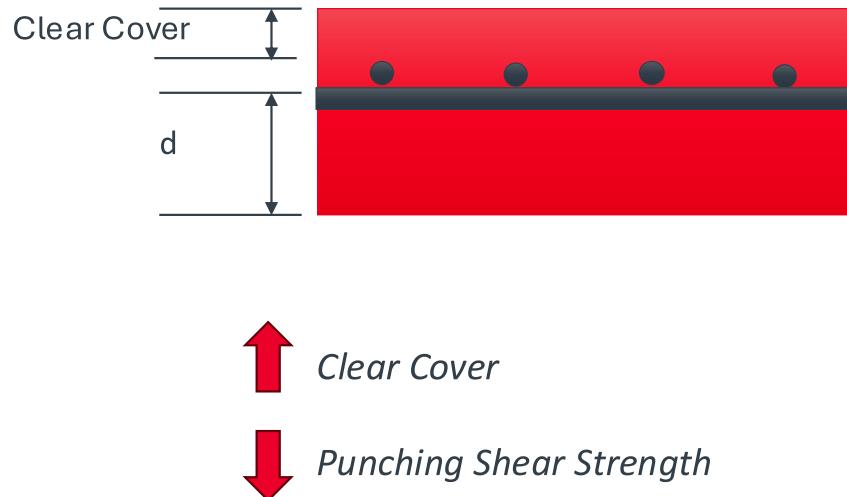
- Punching Shear
 - Dependent on slab depth and concrete strength
 - $V_c = \boxed{4} \sqrt{f'_c} b_o d$
- Current research shows that:
 - Dependent on flexural reinforcement and slab thickness
 - A coefficient of 4 may be unconservative for low reinforcement ratios

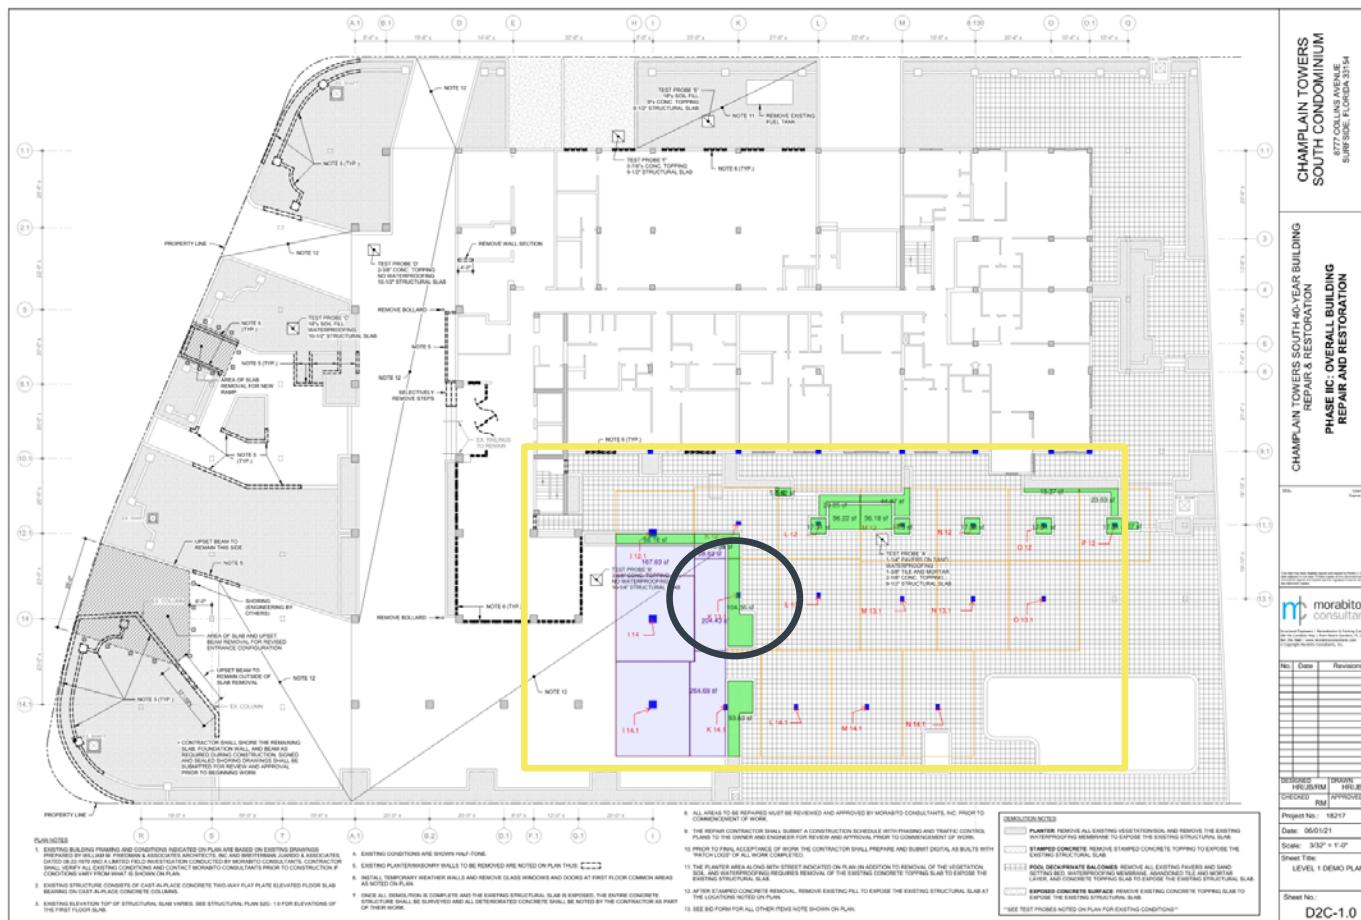
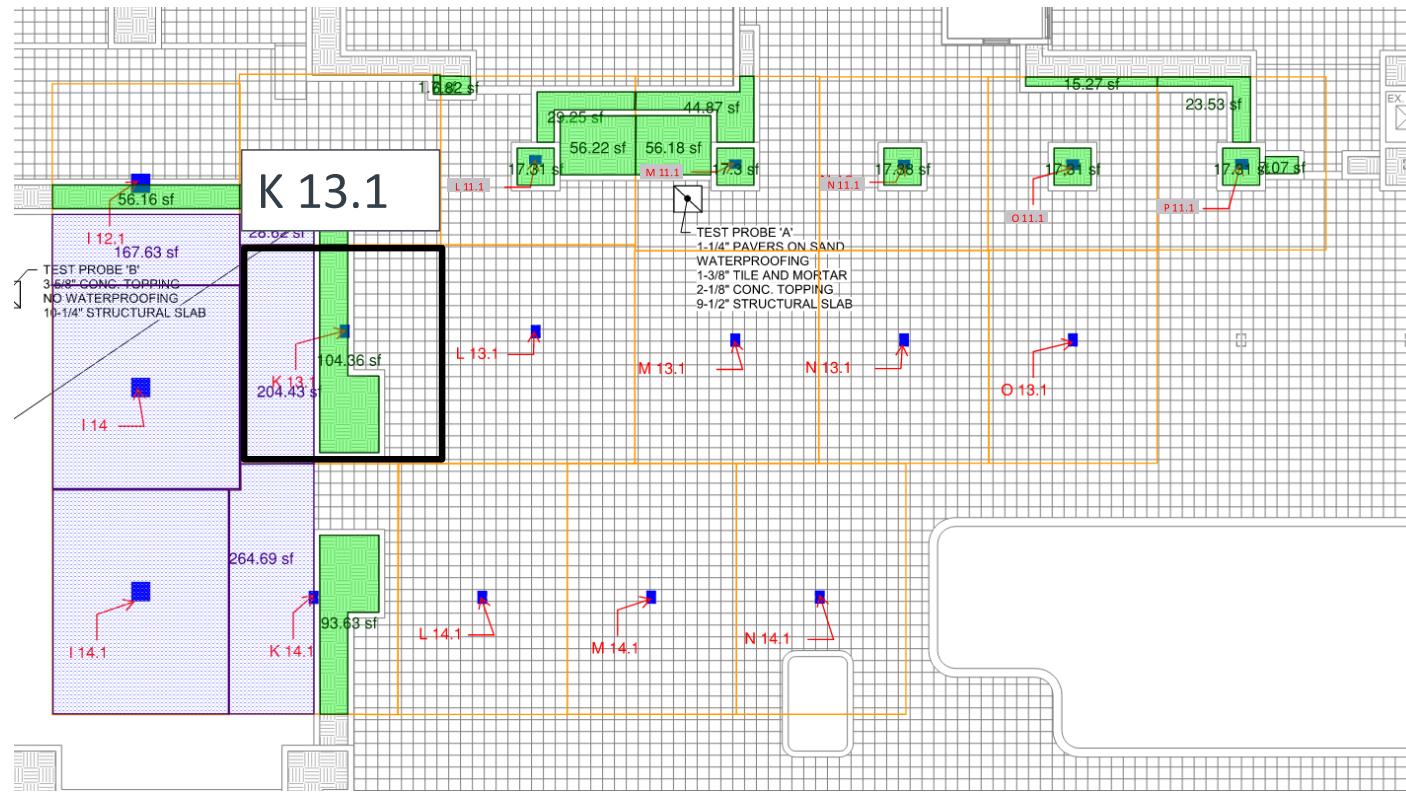
Pool Deck – At Collapse

Pool Deck Punching Shear (Column K 13.1)

As Designed (safety factor)	K 13.1
Size (in x in)	16x12
Nominal f'_c (psi)	4000
Clear Cover (in)	0.75
Factored Load (kip)	266
Reduced Nominal Capacity (kip)	155
Demand to Capacity Ratio	1.72

At Collapse (no safety factor)	K 13.1
Size (in x in)	16x12
Estimated f'_c (psi)	5000
Clear Cover (in)	2.13
Estimated Load (D) (kip)	128
Nominal Capacity (kip)	150
Demand to Capacity Ratio	0.85

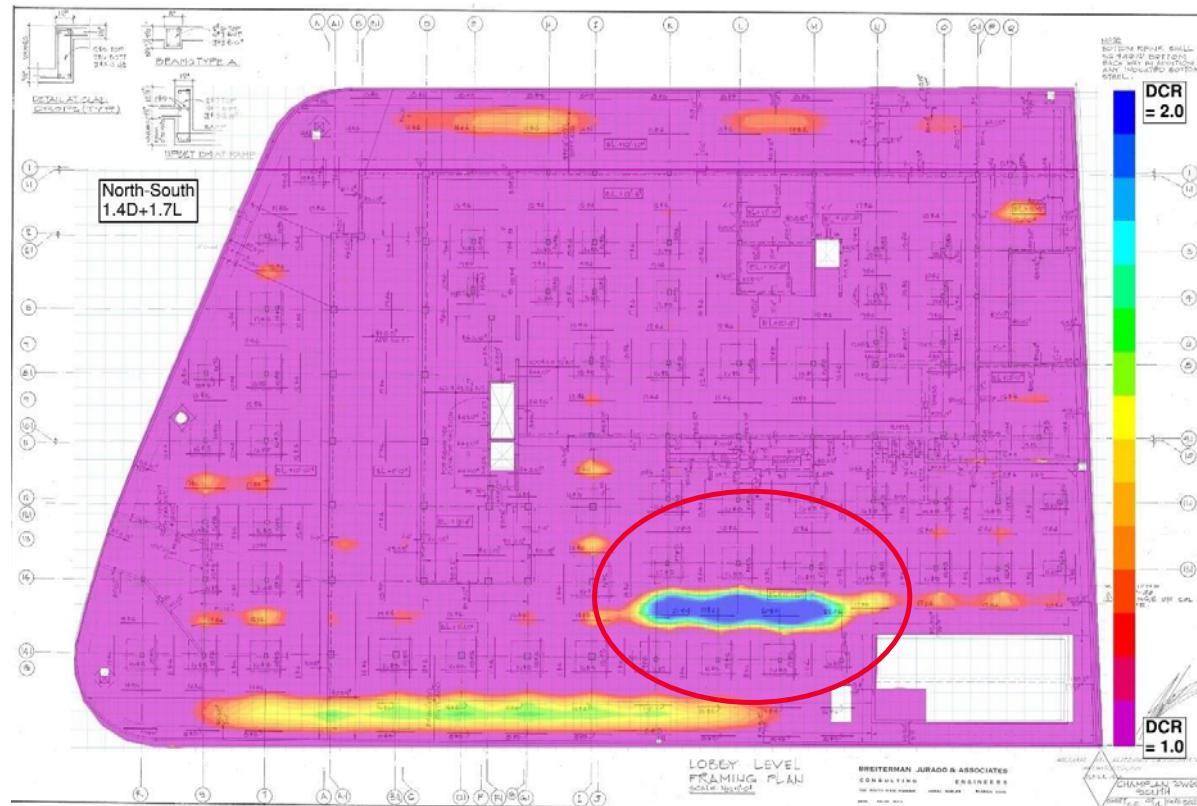
Lobby Level Slab – Finite Element Model

As-Designed Positive Bending, $1.4D+1.7L$, $\Phi = 0.85$

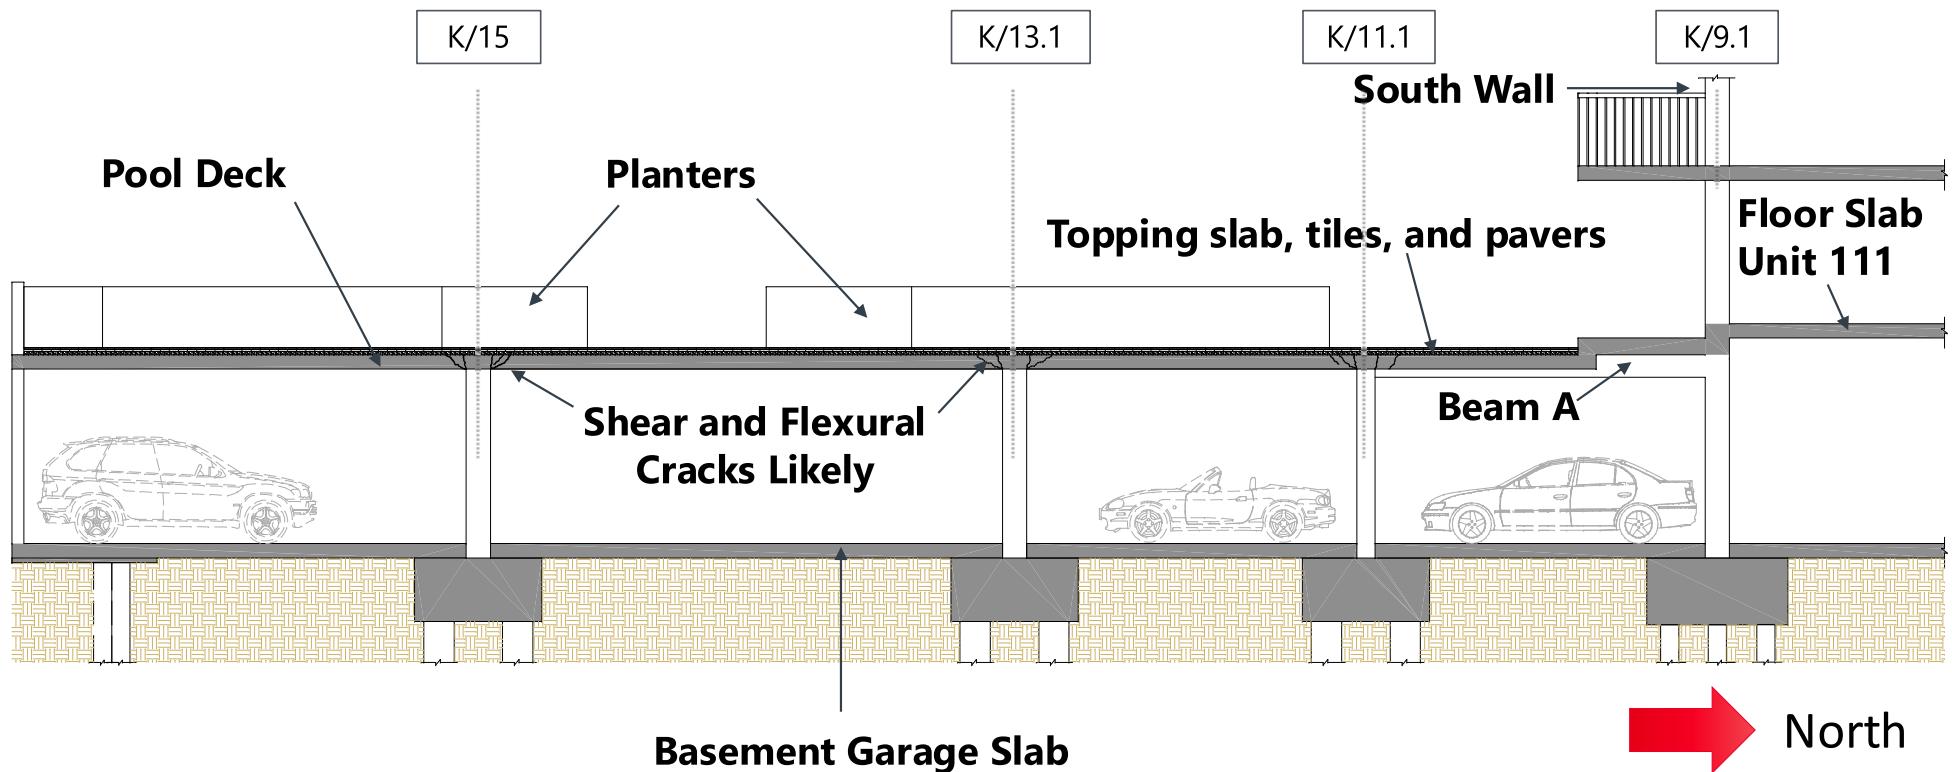
Collapse Hypothesis

Before April 13, 2020

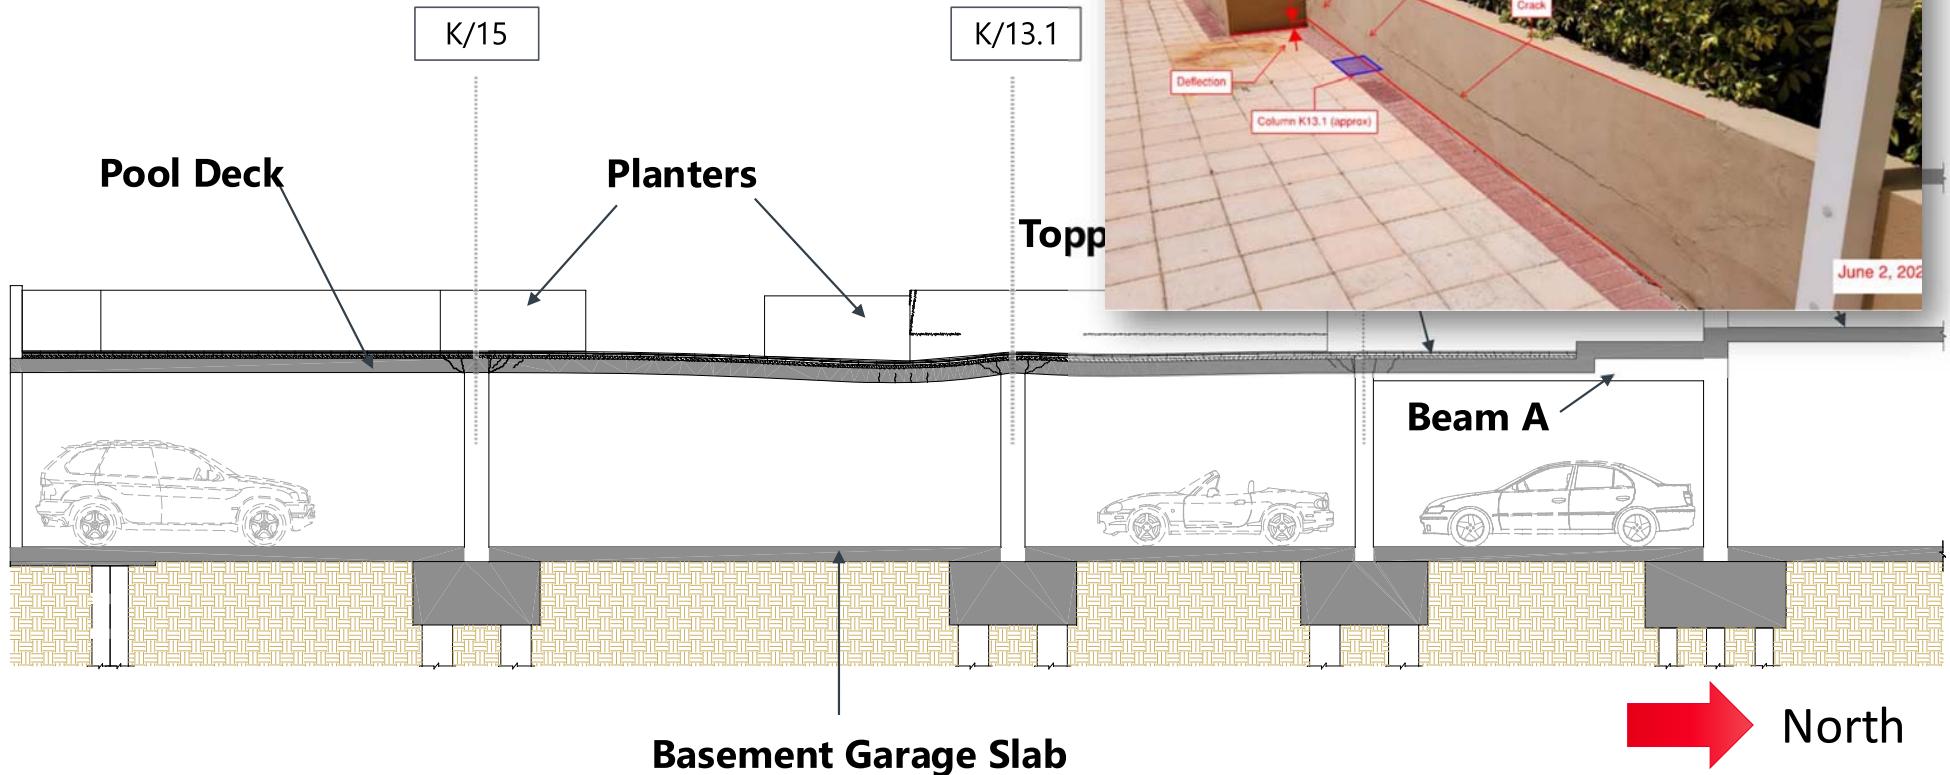
Collapse Hypothesis

After April 13, 2020 and Before June 2, 2021

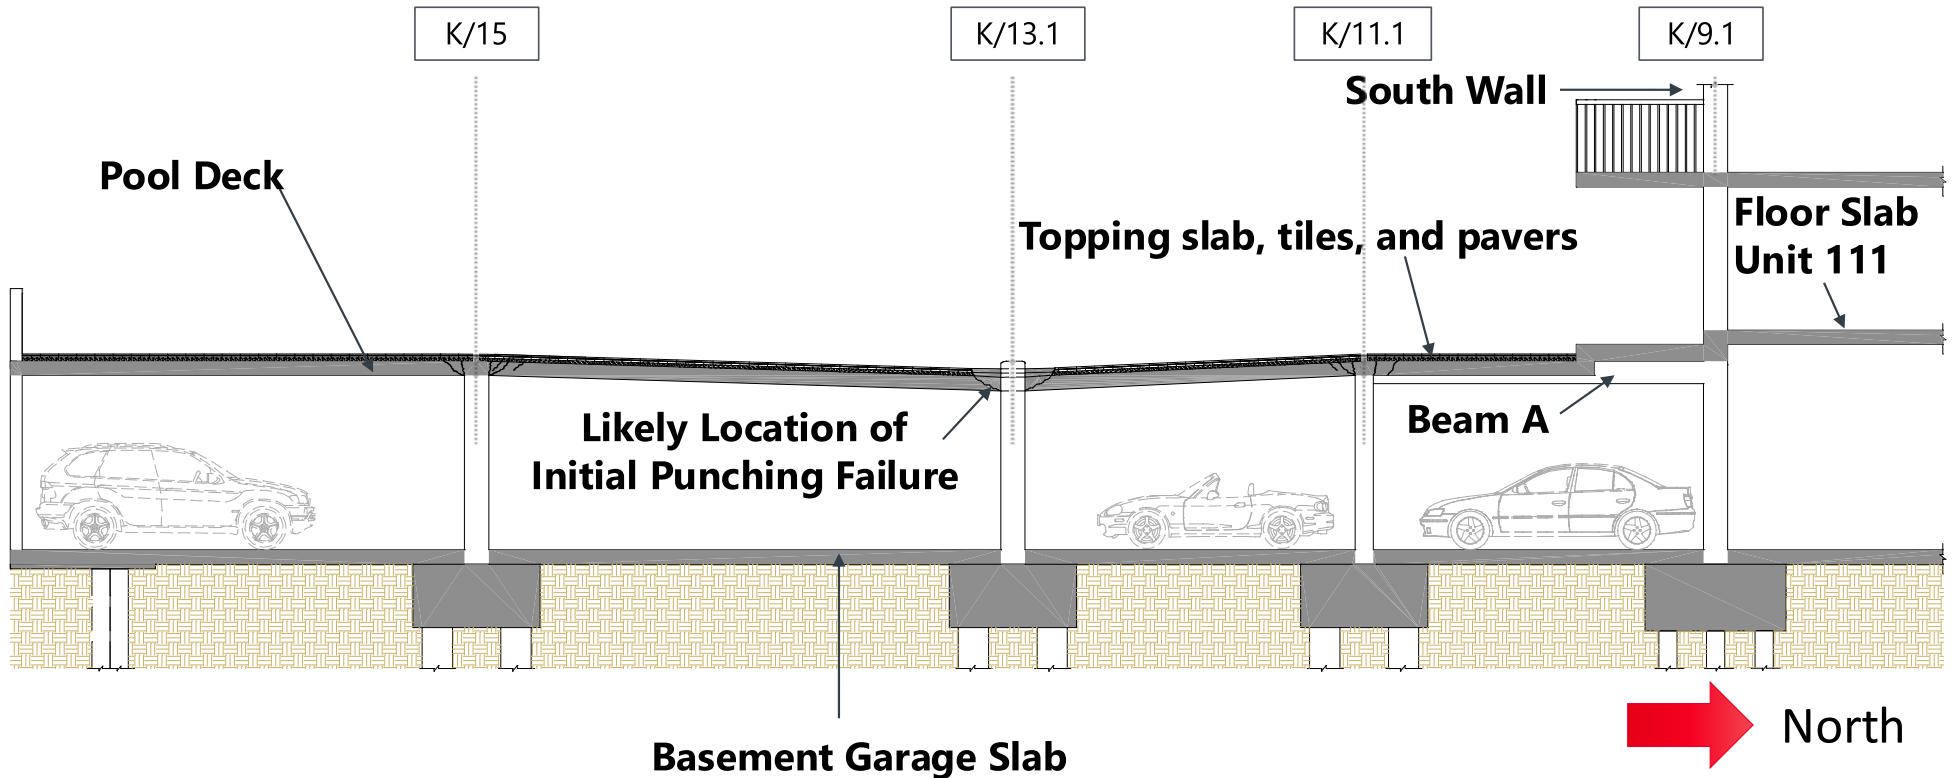
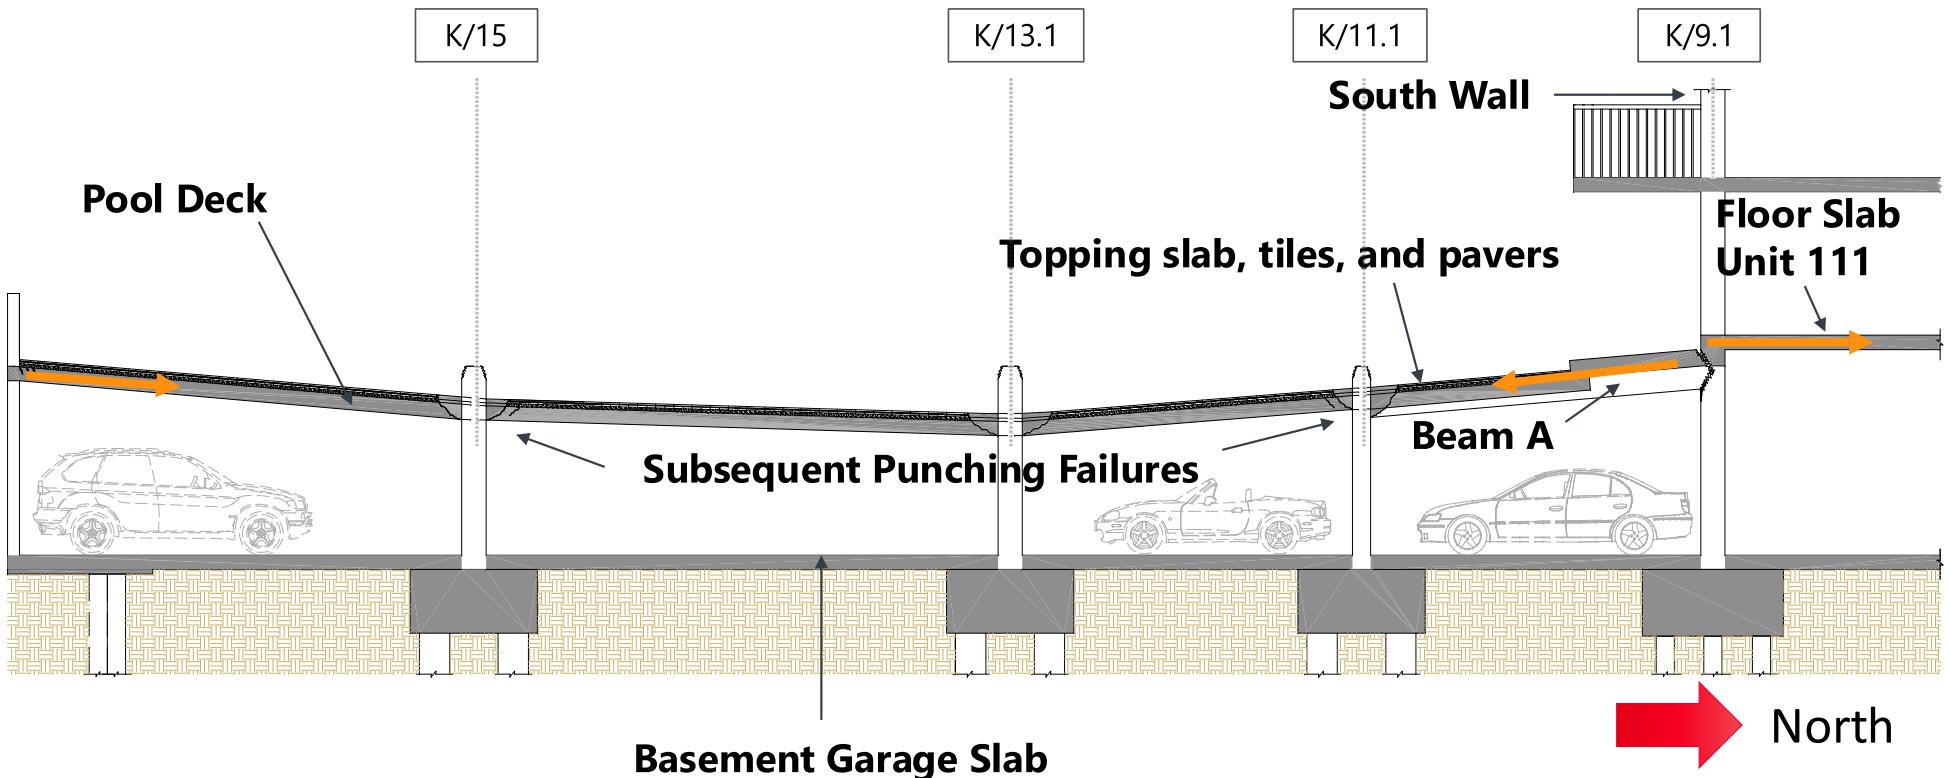
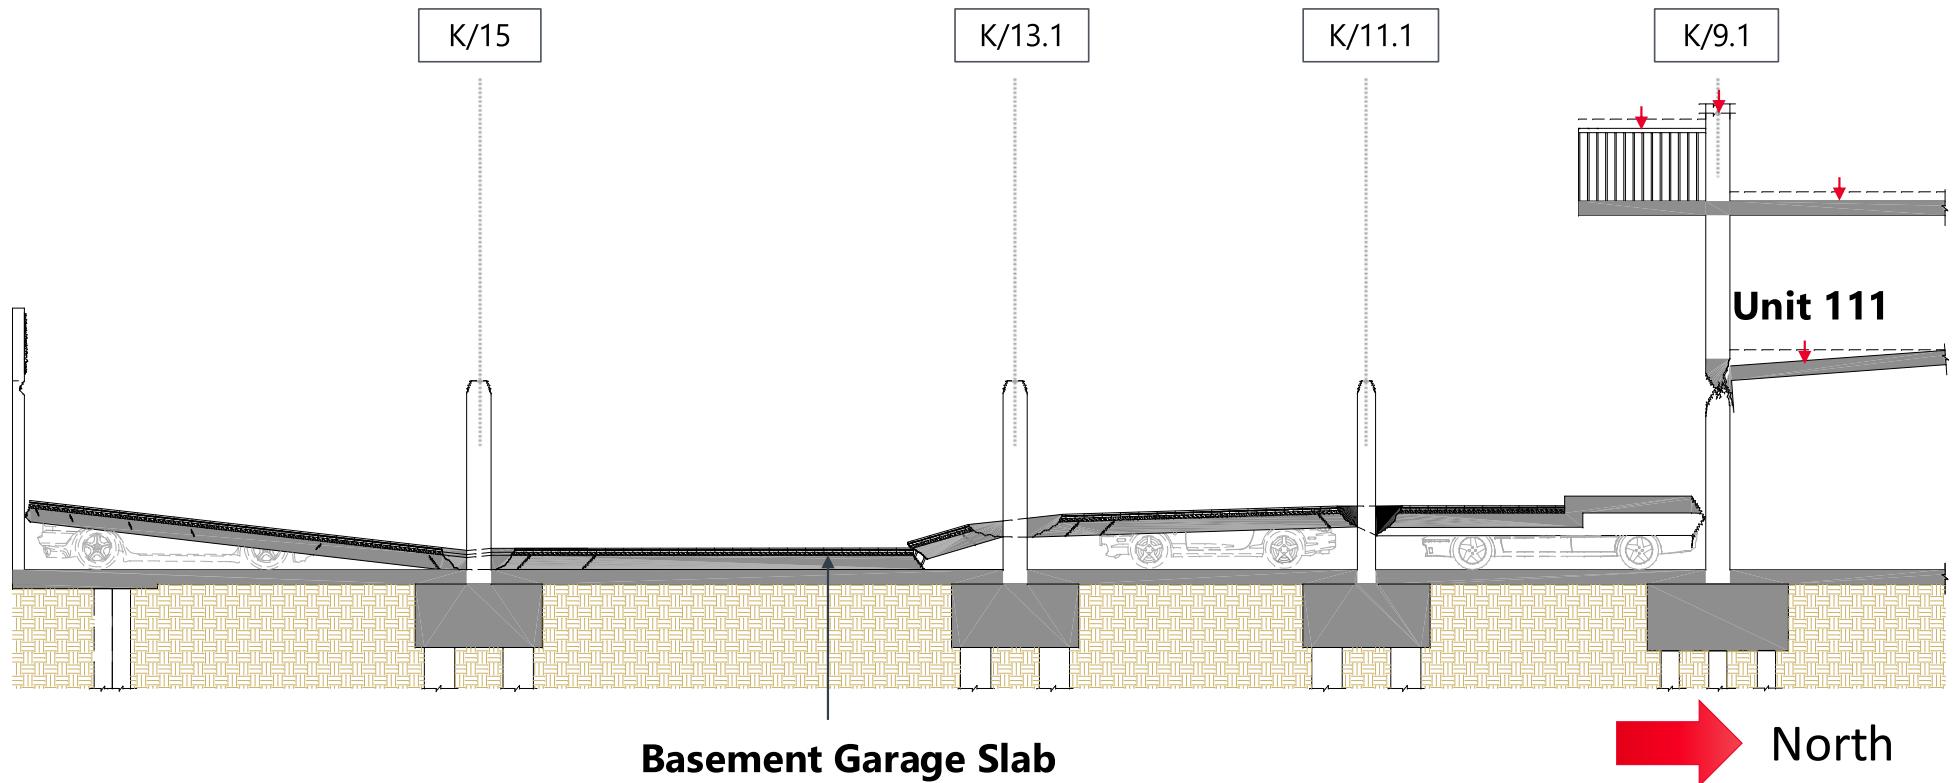
Collapse Hypothesis

June 24, 2021: 1:10 – 1:15 AM

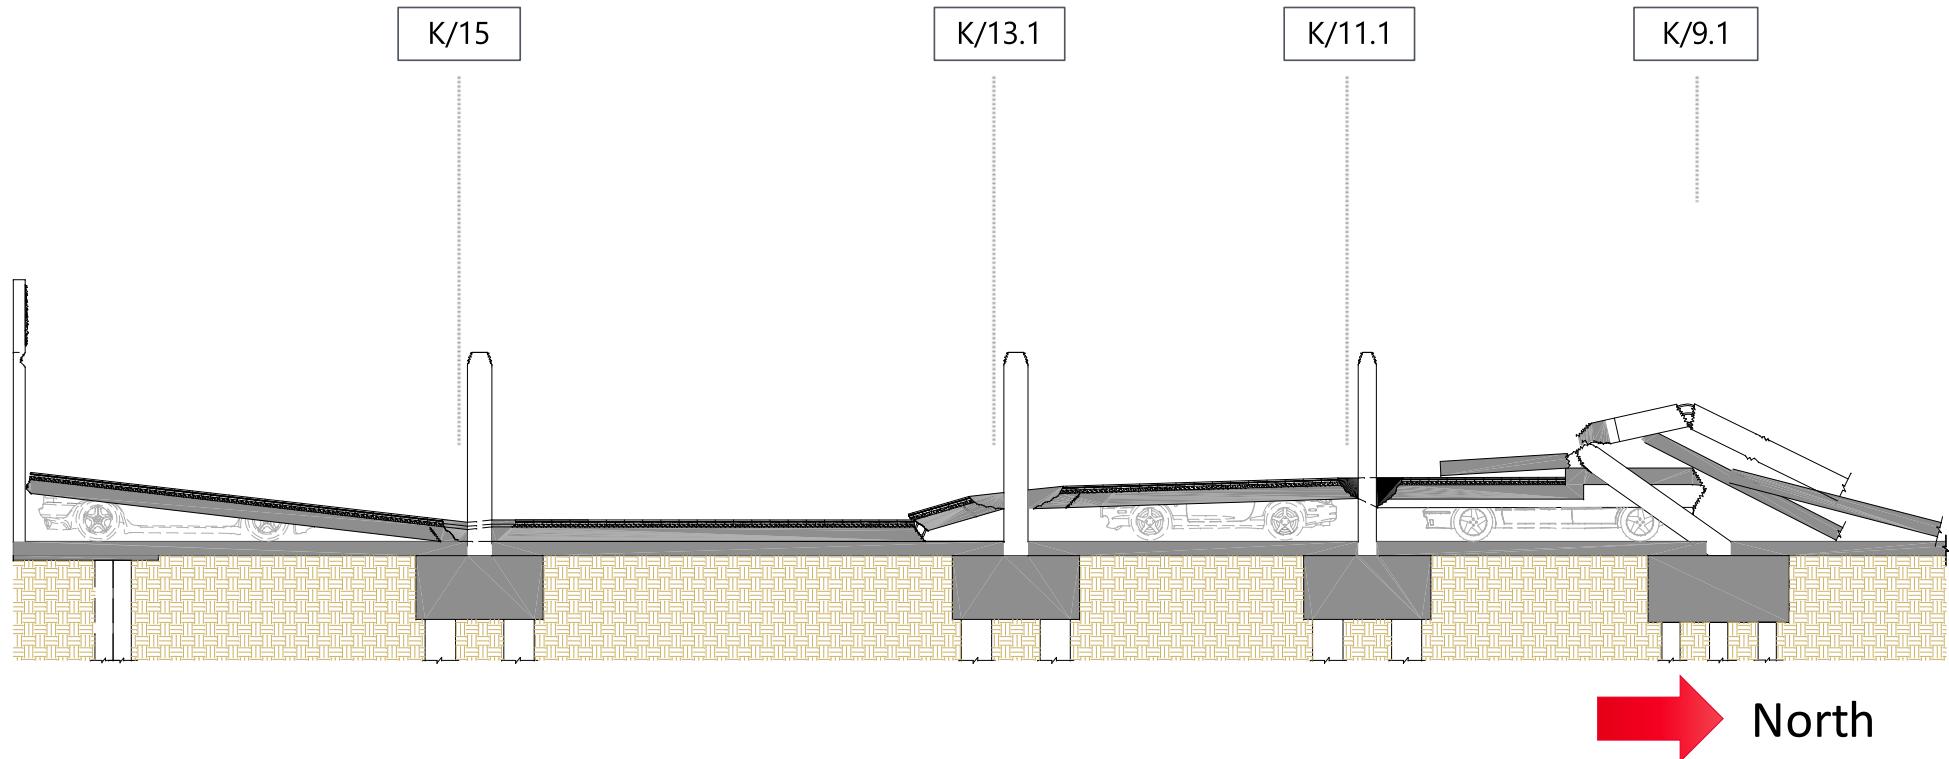
Collapse Hypothesis

June 24, 2021: 1:22 AM
